UTILIZING CONDEMNATIONS, RETIREMENTS AND MODS TO IMPROVE THE STRUCTURAL RISK ANALYSIS OF THE T-38: TURNING TRASH INTO TREASURE

Marcus L. Stanfield, Laura D. Hunt and Isaac T. Grothe

Southwest Research Institute
6220 Culebra Road, San Antonio, TX 78238 USA
Marcus.Stanfield@swri.org

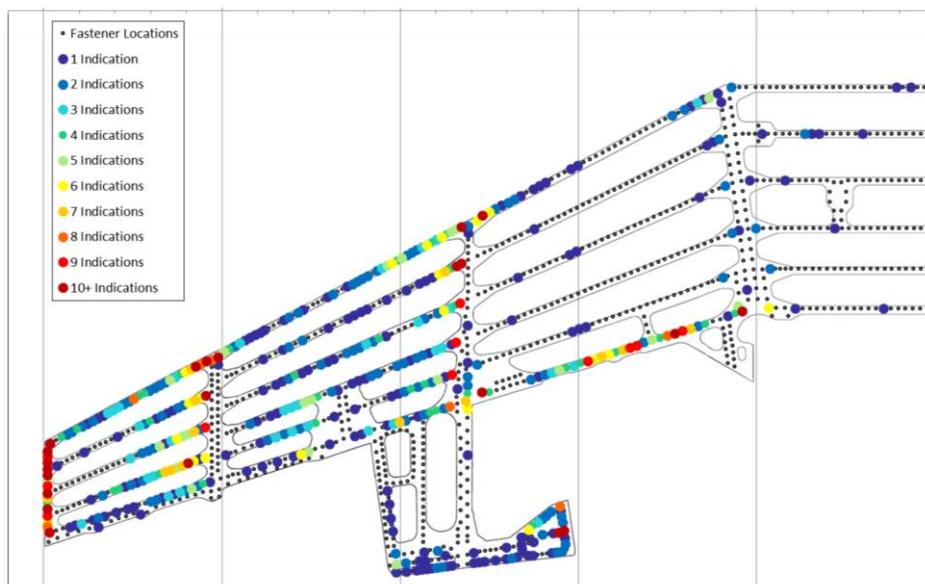
Figure 2: Wing fatigue crack location heat map.

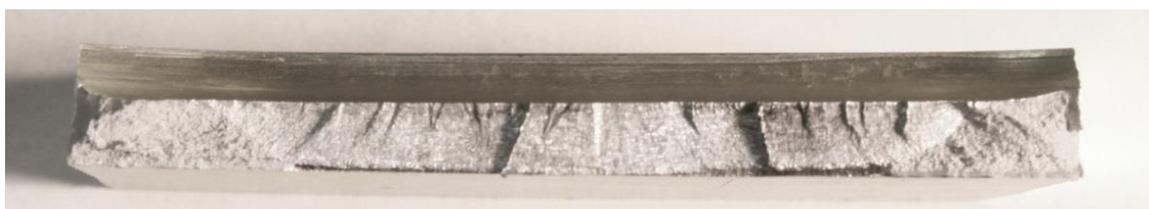
The successful full-scale fatigue test of two T-38 wings under different usages, presented at ICAF2017 [4], resulted in a failure at a mechanically milled pocket in the lower wing skin. Multiple cracks nucleated at machine marks left from the milling process. These cracks linked causing multiple ratchet marks on the crack face. An image of the milled pocket crack is shown in Figure 4.

Figure 4: Wing skin milled pocket fatigue failure.

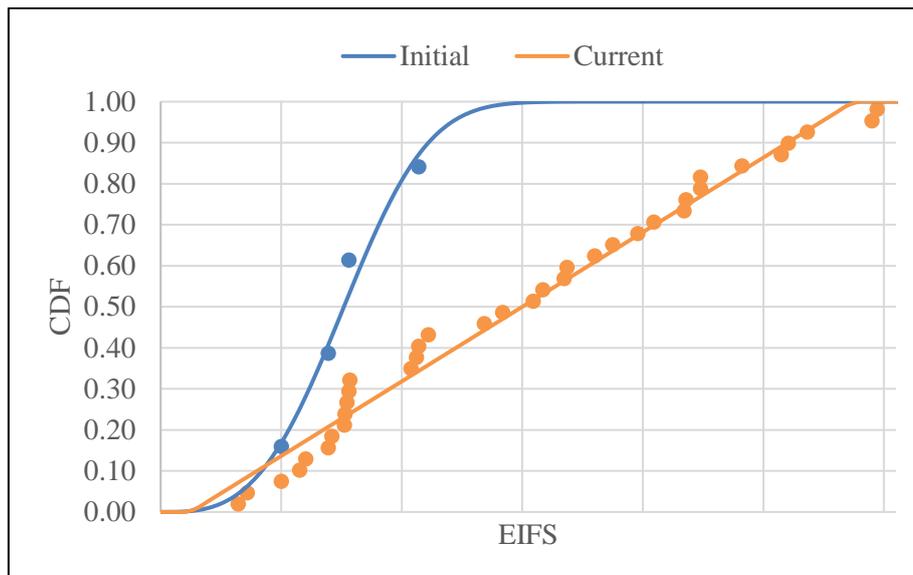
All four locations in the full-scale wing fatigue tests were found to be cracked, left and right side on both wings. These cracks were used to create an initial EIFS Weibull distribution and a risk analysis was performed. From the initial risk analysis, a revisit of the non-destructive inspection method and procedure was warranted. Aircraft wings with a positive indication were condemned and the milled pocket was excised from the wing and sent for failure analysis. Since then, 36 confirmed cracks have undergone a failure analysis and the cracks measured. An EIFS distribution was created that clearly showed a uniform distribution of the data. The uniform distribution arises in manufacturing where a mass-produced part gradually changes dimension through tool wear and increased tool forces between setups [5]. The initial and current EIFS distributions are shown in Figure 5.

Figure 5: Wing skin milled pocket initial vs current EIFS distributions.

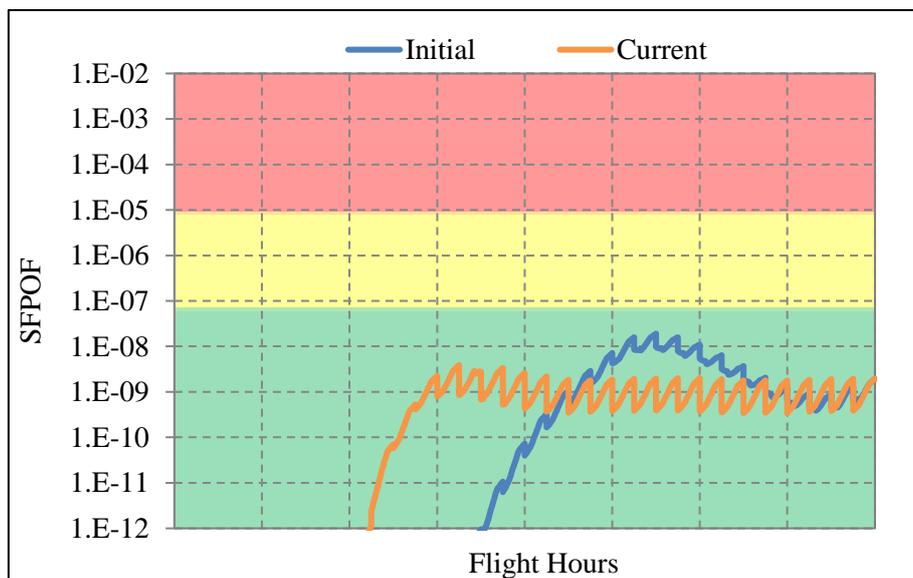
Both EIFS distributions were used in PROF risk analysis keeping all other inputs constant, which is shown in Figure 6. The SFPOF for the current uniform EIFS distribution resulted in six magnitudes greater than the initial Weibull EIFS distribution SFPOF during the early flight hours, resulting in a higher risk earlier in the wing's life. The initial SFPOF accumulates 10 times the risk at its maximum than the current SFPOF. Both EIFS distributions level out to the same risk late in life.

Figure 6: Wing skin milled pocket risk analysis for initial vs current EIFS distributions.

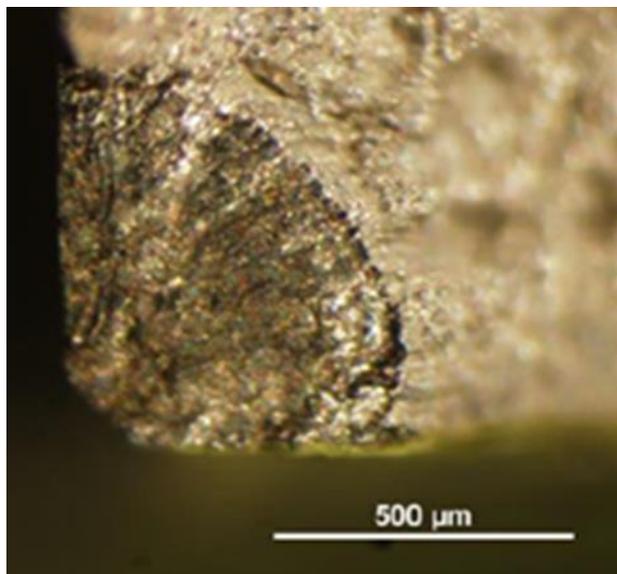
with measured cracks at this location. Out of these findings, the largest recorded crack size was 1.8 mm, which is an order of magnitude less than the critical crack size. Also of note was that the failure analyses revealed that all cracks had nucleated from the faying surface of the hole, whereas the DTA assumed that the crack originated at the countersunk knee. An image of a faying surface crack is shown in Figure 7.

Figure 7: Faying surface corner crack.

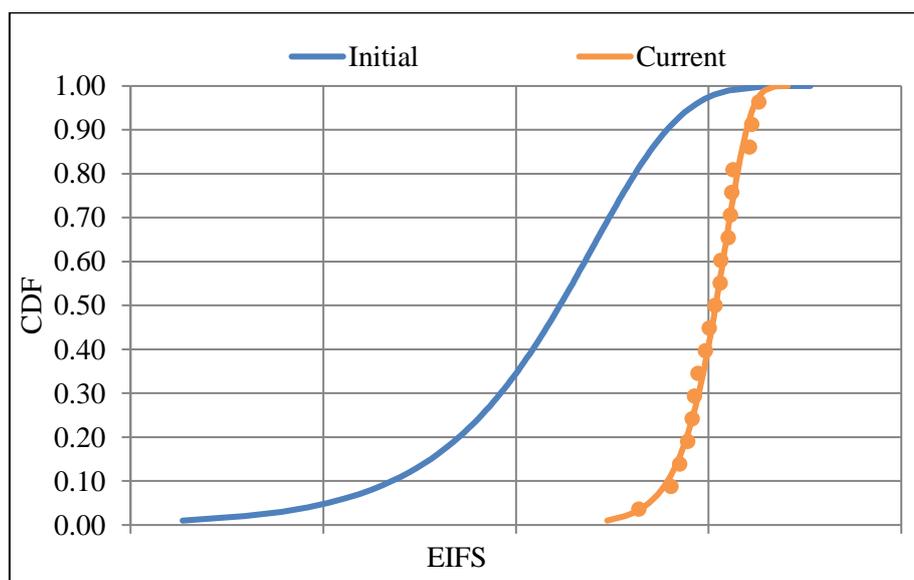
The risk analysis was revisited with two major changes: 1) the crack growth was reanalyzed with the crack nucleating from the faying surface of a countersunk hole instead of the knee, and 2) an EIFS distribution was created based on the failure analysis crack findings and new crack growth curve. Figure 8 shows two EIFS distributions and one dataset. The new EIFS distribution using the faying surface model is the solid orange line and the legacy coldworked fastener hole EIFS distribution is the blue line. The reduced dataset used to create the new distribution is plotted as orange circles. Interestingly, the new distribution contains larger cracks than the legacy coldworked fastener hole distribution. However, putting the crack at the faying surface rather than the knee increased the analytical life by a factor of almost four.

Figure 8: Coldworked hole initial vs. current EIFS distributions.

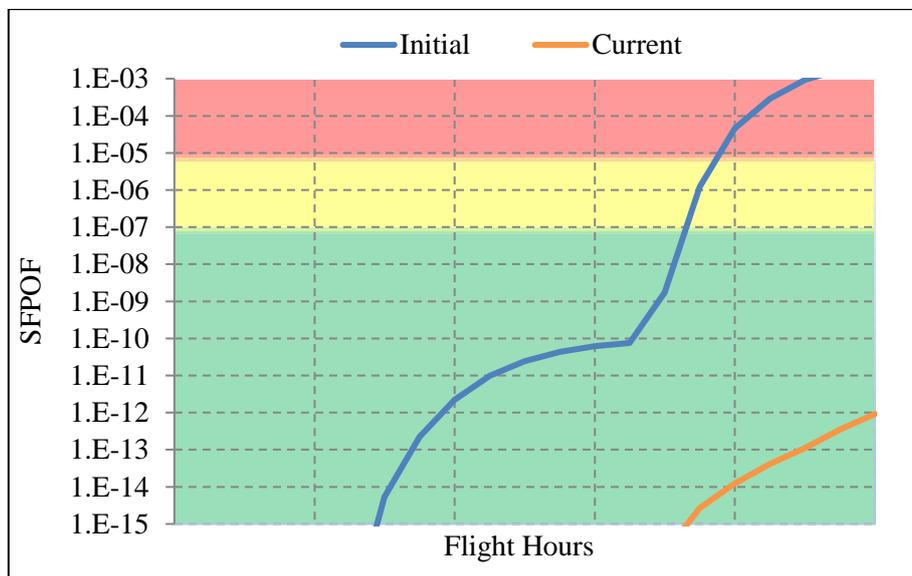
The faying surface crack growth curve, normalized stress intensity factor, and new EIFS distribution were input into a PROF risk analysis. With all other inputs remaining the same, the new results showed that the SFPOF remained below 10^{-7} for the expected lifetime of the wing. Thus, teardowns from retired and condemned wings identified the true crack location and were essential for lowering the risk and preventing unwarranted extra inspections. The initial and current SFPOF curves are shown in Figure 9.

Figure 9: Coldworked countersunk hole risk analysis for initial vs current EIFS distributions.

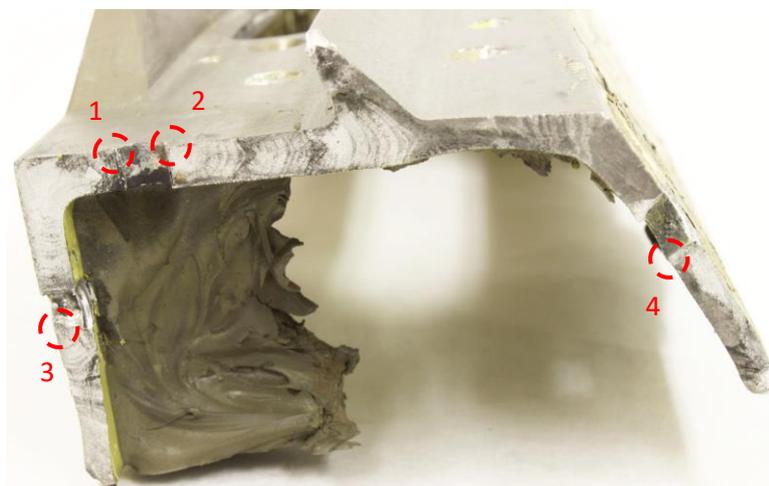
In 2017, a crack was found on a fuselage longeron from a routine visual inspection of the area. This was the first confirmed crack at this location on a high time aircraft. The aircraft was located at a maintenance facility where the fuselage modification program was performed. The longeron was removed and replaced and the cracked longeron sent for a failure analysis investigation. The failure analysis determined that the crack was propagated by fatigue and nucleated at a fastener on the faying surface shown in Figure 10. Sites 1 and 2 are the primary cracking locations, where sites 3 and 4 are secondary cracking (i.e. continuing damage).

Figure 10: Fuselage longeron fatigue failure.

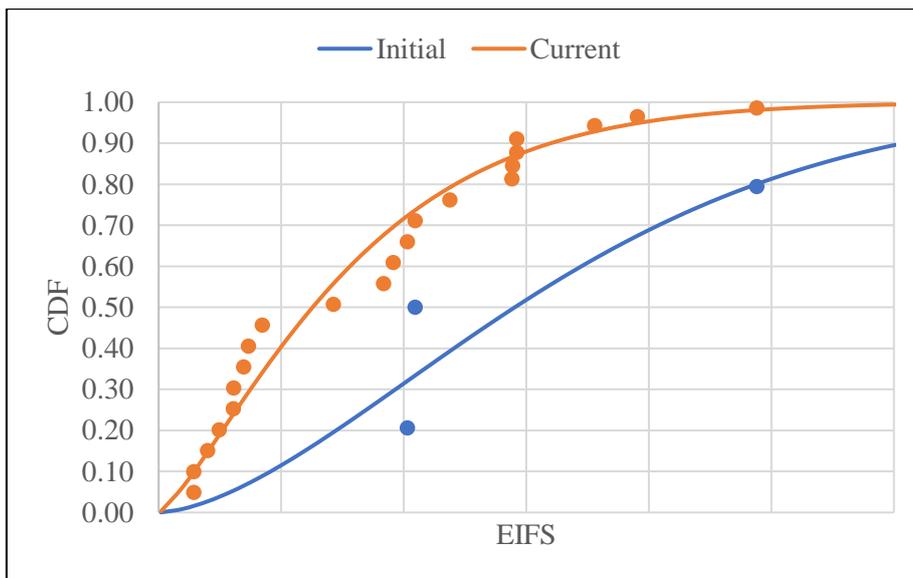
At that time, select parts were removed from the fuselage modification program aircraft and inspected. Two additional crack indications were broken open to measure crack sizes. Since the initial analysis performed in 2017, there have been 24 confirmed cracks at this location. It was observed that 10 of these cracks were double cracks (i.e. a crack on each side of the fastener) and 14 were single cracks. There was no apparent bias between left and right, or outboard/inboard of the fastener. Two DTA curves were created for both the double crack and single crack scenarios to aid in the determination of the corresponding EIFS of the primary crack. An EIFS of each finding and a Bernard's approximation for Median Ranks (BMR) were calculated and used to create a Weibull EIFS distribution. The initial and current EIFS distributions are shown in Figure 11.

Figure 11: Fuselage longeron initial vs current EIFS distributions.

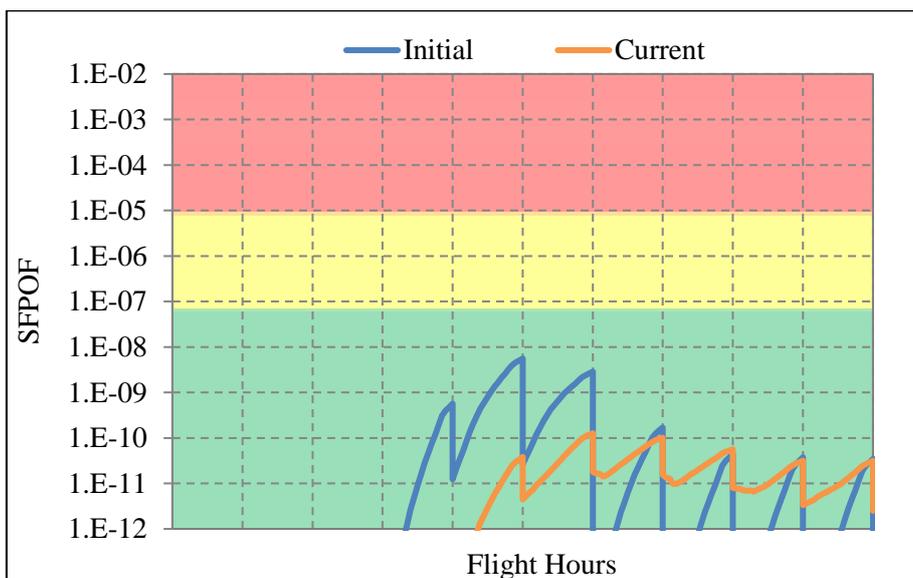
Both EIFS distributions were used in the PROF risk analysis keeping all other inputs constant, which is shown in Figure 12. The SFPOF was reduced by 1/100th at its greatest point for the current EIFS distribution. The initial EIFS curve returns to the current EIFS curve after several inspections have occurred. The reduction in risk has the potential to extend the inspection interval while maintaining an acceptable amount of risk.

Figure 12: Fuselage longeron risk analysis for initial vs current EIFS distributions.
