A REVIEW OF POLISH AERONAUTICAL FATIGUE AND STRUCTURAL INTEGRITY INVESTIGATIONS DURING MAY 2019 TO APRIL 2023

ICAF 2023

The 38th Conference and the 31st Symposium of the International Committee on Aeronautical Fatigue and Structural Integrity, Delft, The Netherlands, June 26 - 29, 2023

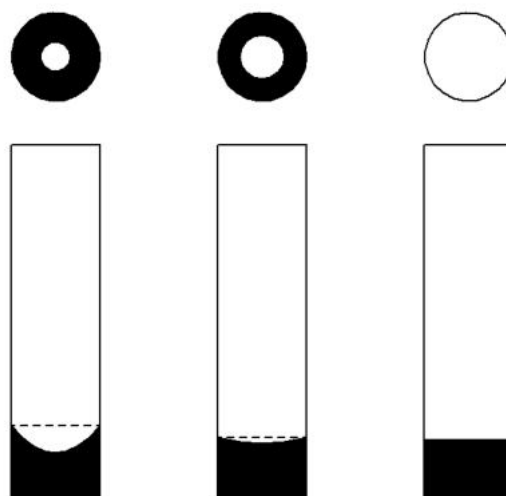
Below (Fig. 1), examples of the correct and bad layout of the solder in the honeycomb seal are schematically presented.

Fig. 1. Examples of the correct and bad layout of the solder in the sealant cell

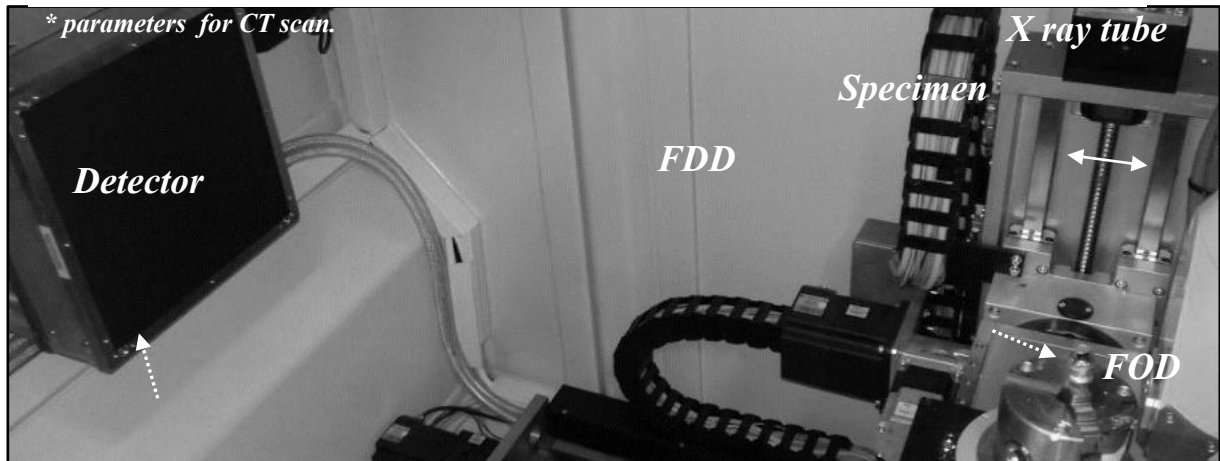
Fig. 3. CT System with parameters used for tested specimens.

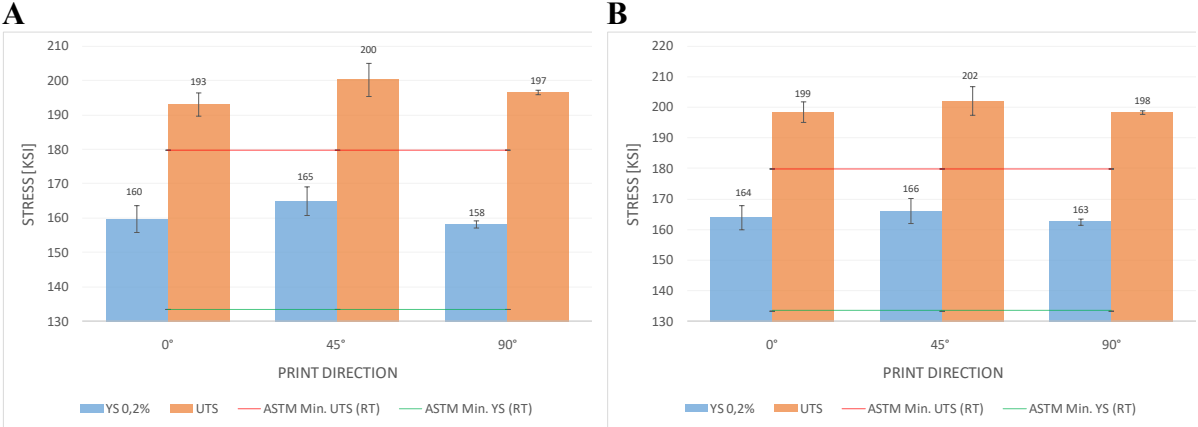
the printing direction 0°. The number of supports affects the results of mechanical tests. The results for yield strength and ultimate tensile strength are more repeatable for samples without support (90°) compared to samples with supports (0°, 45°).

Fig. 5. Results for tensile tests for samples D5-A and D6-B (yield strength 0.2% - YS 0,2%, ultimate tensile strength - UTS).

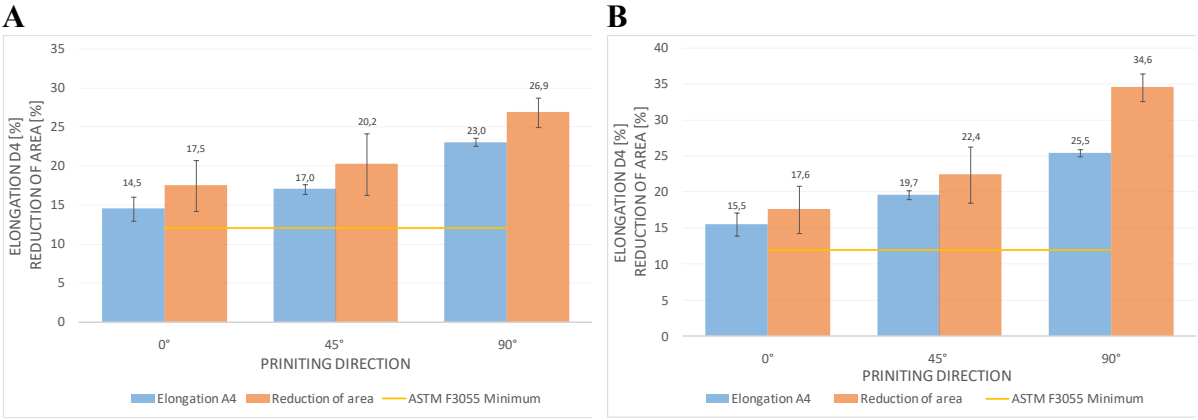
As regards elongation and reduction of area (Fig. 6), it was observed that the printing direction impacted the results more significantly. The lowest elongation and reduction of area was observed for printing direction 0° while the highest result was obtained for 90°. The supports caused the occurrence of more cracks and pores at the support surface area, which reduced the ductility of the material.

Fig. 6. Results for tensile tests for samples D5-A and D6-B (elongation A4, reduction of area).

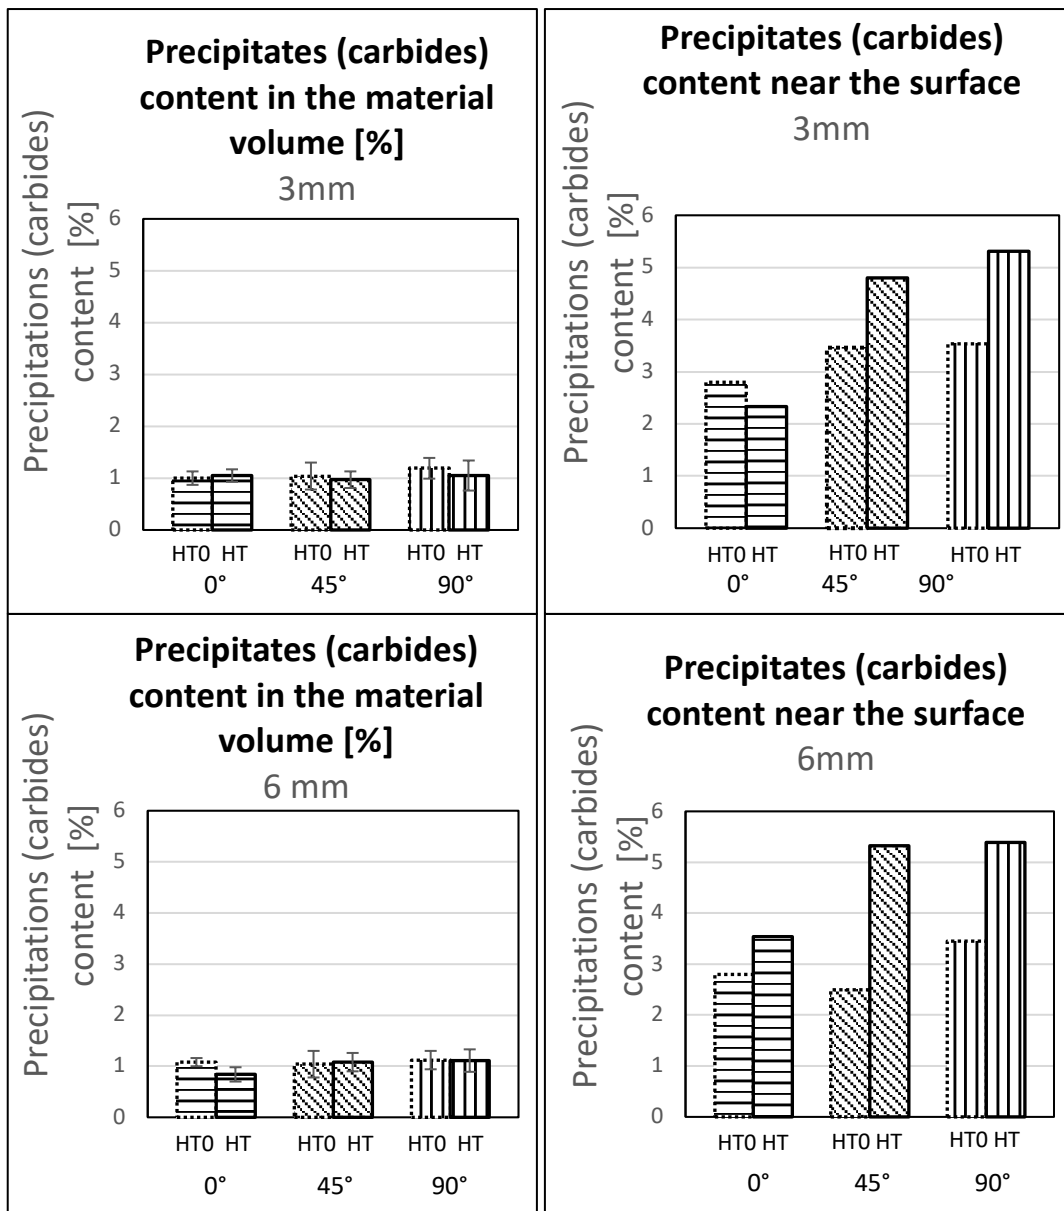
Fig. 13. Carbides content in printed bar rods.

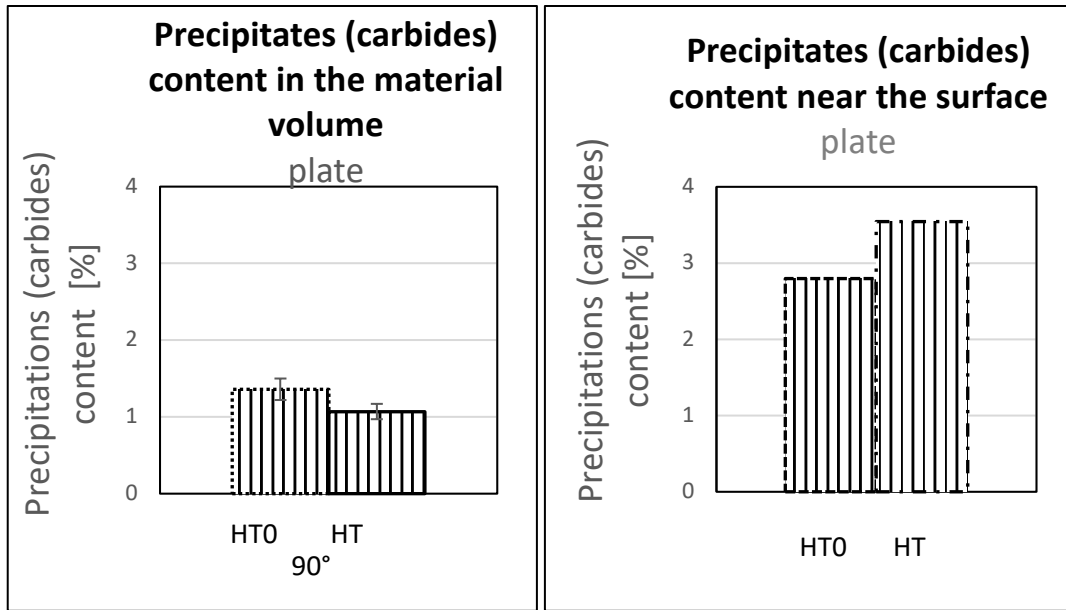
Fig. 14. Carbides content in plate type specimen.

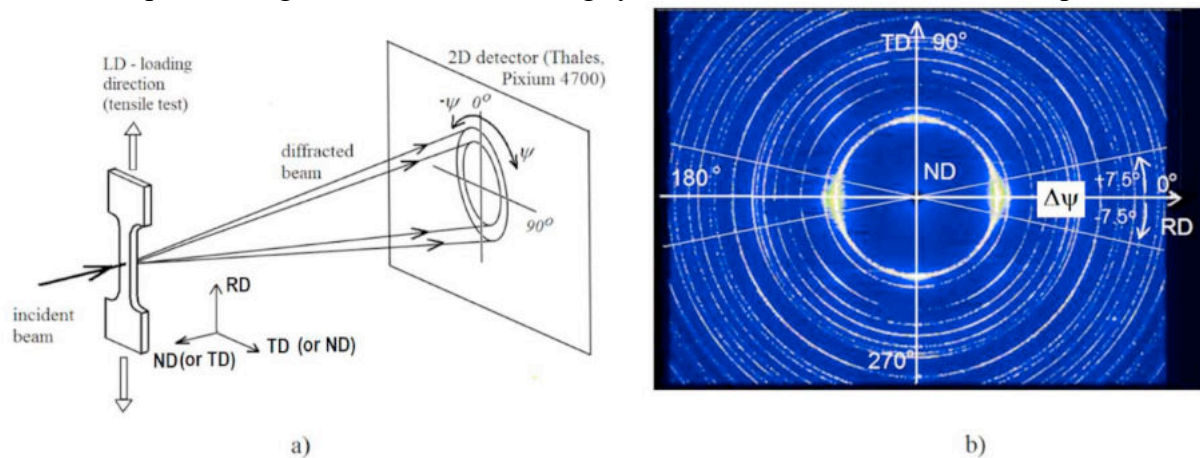
Fig. 1. The experimental setup used for lattice strain measurement at the ID15 synchrotron beamline (a) and the 2D image obtained for the studied duplex steel (b). The diffraction rings corresponding to reflections from ferrite and austenite and two “cake shape” sectors, with an angular size of $\Delta\psi$ are shown.

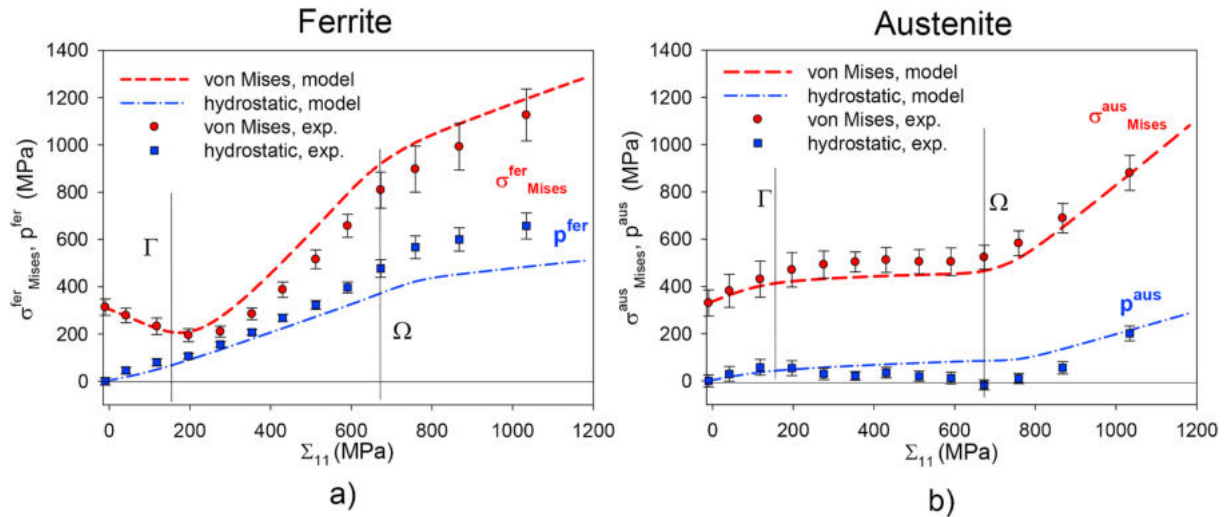
Fig. 3. Evolution of the von Mises and hydrostatic stresses determined from mean phases stresses for a) ferrite and b) austenite. The experimental values (points) are compared with model prediction (lines). Specimen with RD//loading direction.

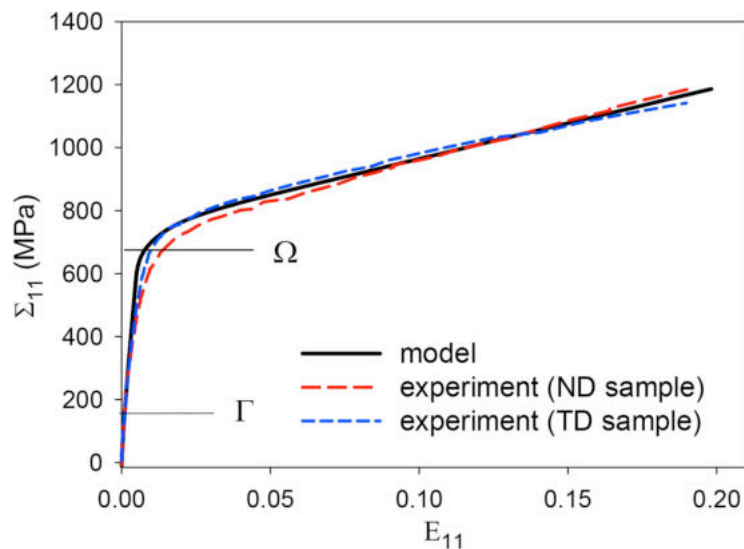
Fig. 4. Macroscopic experimental and model curves for tensile test performed for duplex steel.

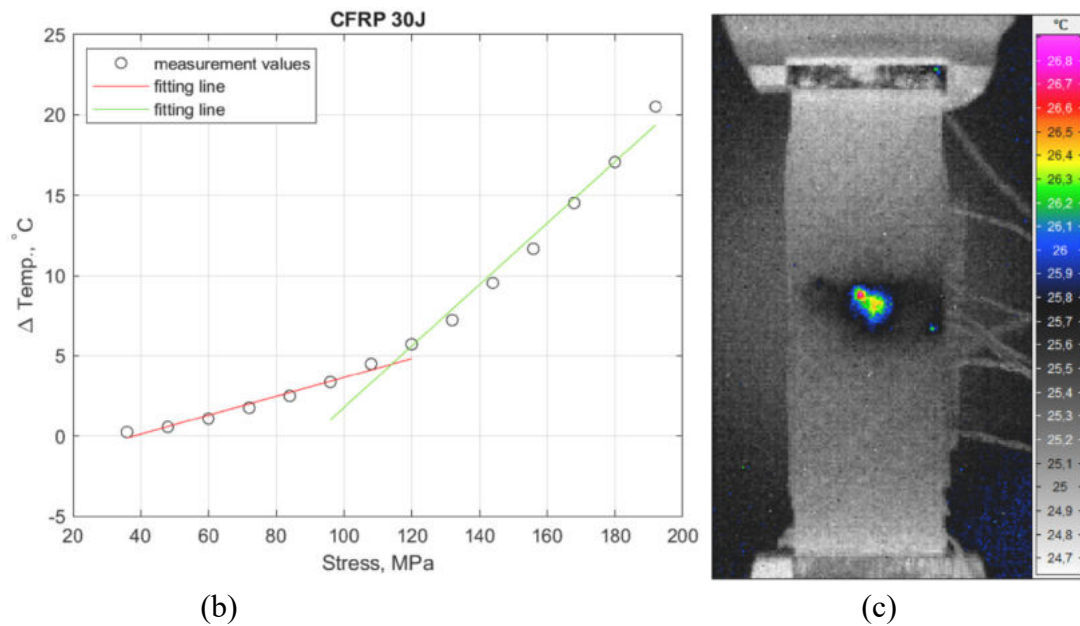
Fig. 1. The results of testing: (a) temperature response during step testing, (b) the results of determination fatigue limit, and (c) the results of identification of damage [3].

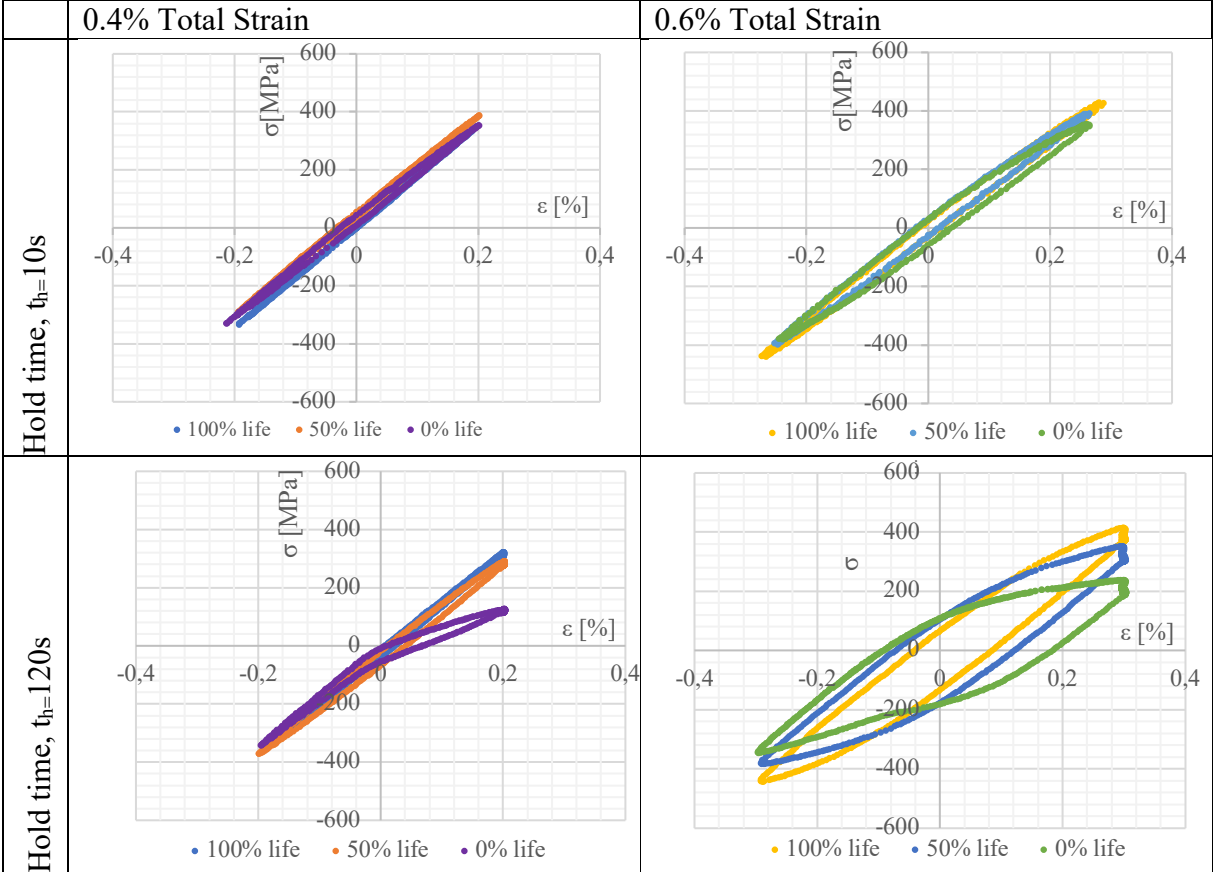
Figure 1. Hysteresis loop of the LCF test shown for 100%, 50%, and 0% of life. LCF, low cycle fatigue.

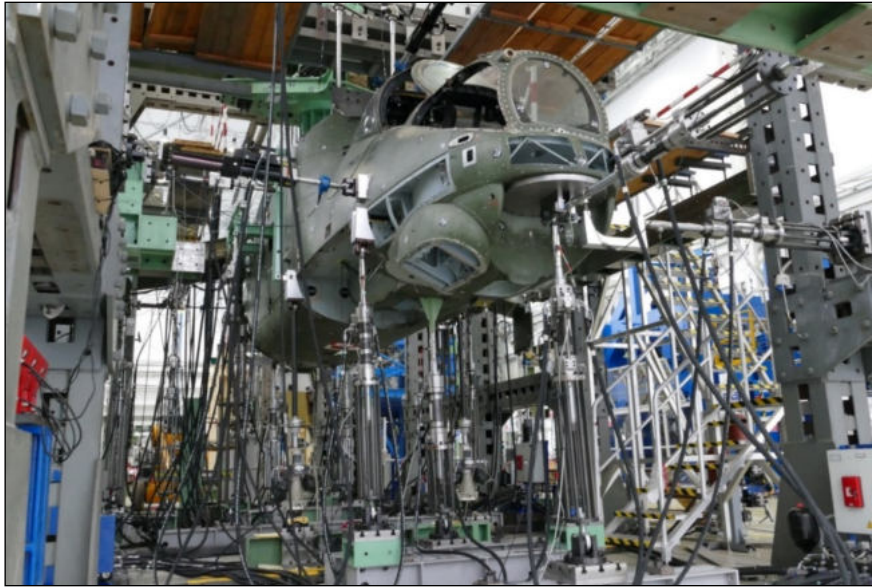
Figure 1. Mi-24 helicopter installed on the test rig

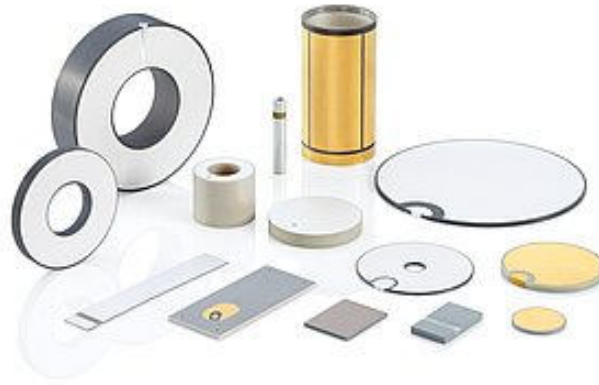
Figure 4. Different type of PZT transducers¹¹

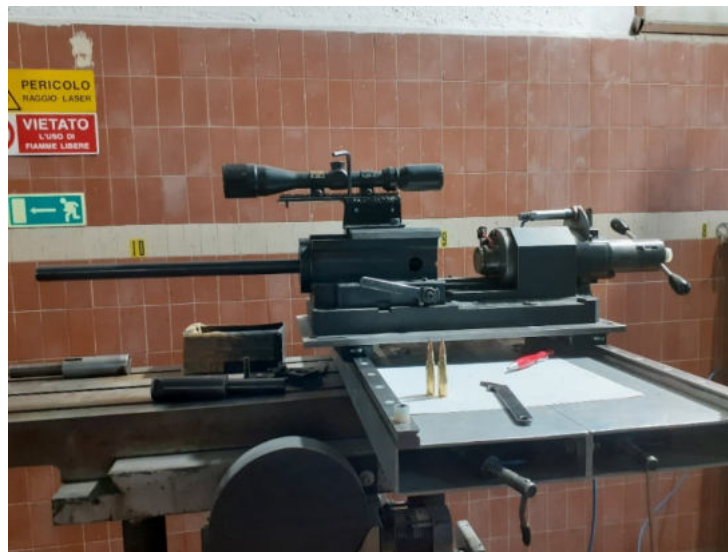
Figure 6. Ballistic impact test bed

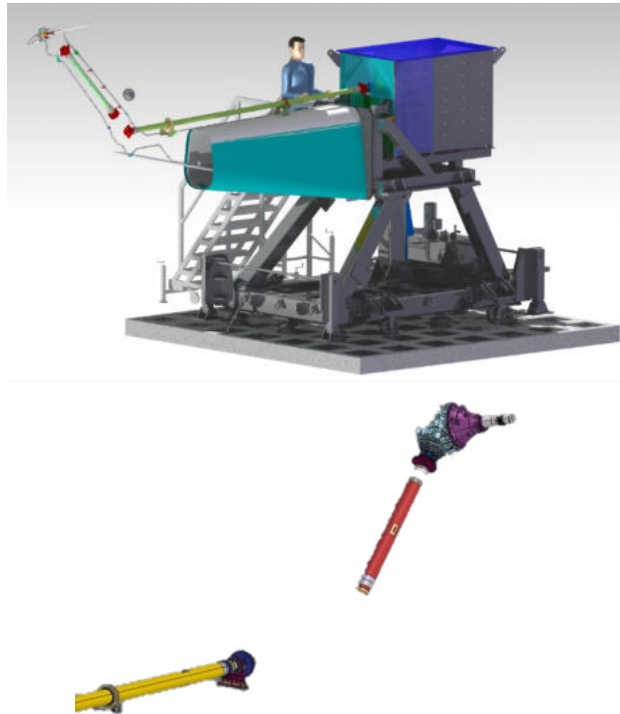
Figure 2. Ground test stand for impact detection and the region of interest

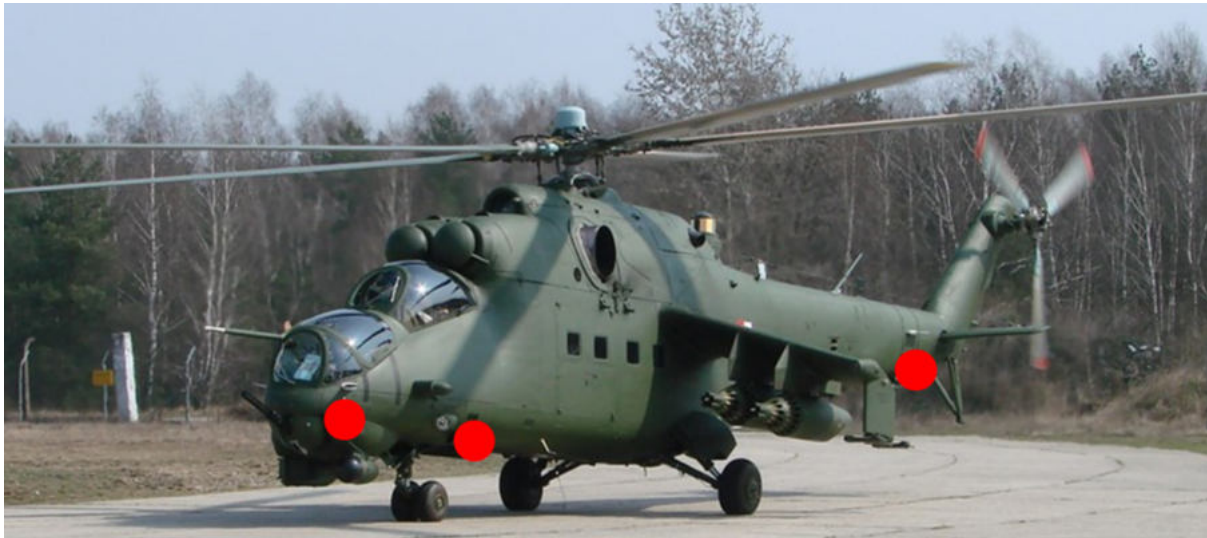
Figure 2. Location of sensors on the airframe of the Mi-24 helicopter
