Review of Aeronautical Fatigue Investigations in Switzerland

*Swiss National Review
of the International Committee on Aeronautical Fatigue and Structural Integrity*

Document: ZAV-KOR2023-001

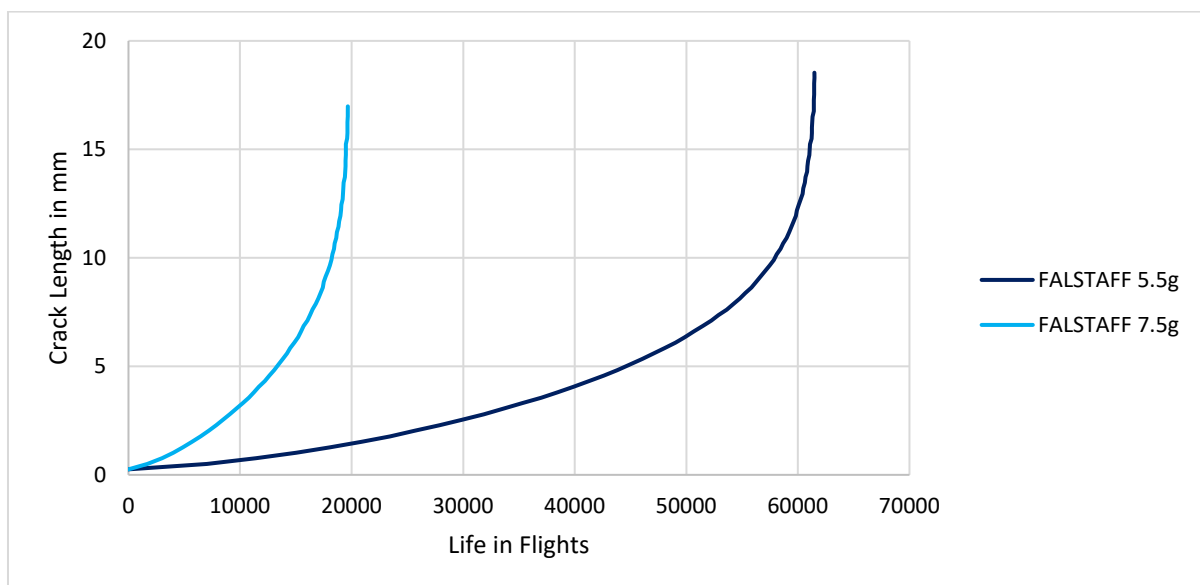
The resulting stress distribution is further used for a crack growth (CG) calculation using AFGROW in the form of the normalised stress correction factor. The spectrum is left unchanged: The FALSTAFF spectrum is scaled to the reduced civilian envelope, with the number of cycles doubled and the second part inverted to have a symmetrical spectrum (which is assumed to be present due to the fact that cracks both on the upper and lower side of the spigot were found). However, the evaluation with AFGROW shows that the second inverted part has only a very small share in the damage contribution. It can also be assumed that the use of FALSTAFF leads to conservative results as the aircraft is now mostly used for passenger flights with comparatively few manoeuvres and few display flights only. The initial and critical crack sizes are currently under investigation. The total CG life of the component calculated with AFGROW is shown in Figure 9. It will be used subsequently to estimate the remaining fatigue life of the component. It can also be seen that the reduction of the maximum load factor from 7.5 to 5.5 markedly extends the fatigue life by a factor of approximately 3.

Figure 9: CG life of the leading edge spigot for both the civilian and military use

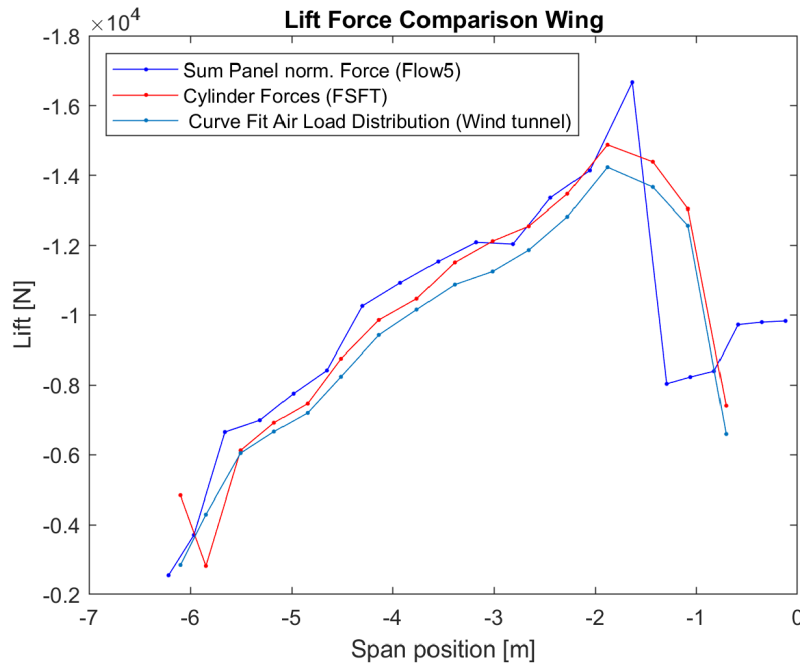
The first step for the estimation of the future fatigue life is driven by the intended operation. The aircraft will be mostly used for air shows and the associated ferry flights. Only a limited number of flight hours per year is foreseen. Furthermore, the maximum allowed load factor is reduced to $n_z = 5.5$. A flight envelope was thus created which was used to determine the most critical load cases. The air loads were subsequently calculated for a load case with $n_z = 6.67$ at $Ma = 0.6$, since validation data from the FSFT and from wind tunnel tests was available. From the different tools evaluated, Flow5 showed the best agreement as it can be seen in Figure 13. A reasonable correlation between the forces determined with Flow5, the cylinder forces from the FSFT and the wind tunnel data can be observed. Using these loads, the bending and torsion moments of the wing can be calculated. The future work consists of developing an appropriate model to determine the loads at the four aforementioned critical locations. The spectrum will be a FALSTAFF spectrum scaled to the actual envelope, as only limited data of the actual spectrum is available. Only then, the criticality can be assessed using CG calculations.

Figure 13: Comparison of lift forces from panel code, FSFT, and wind tunnel data

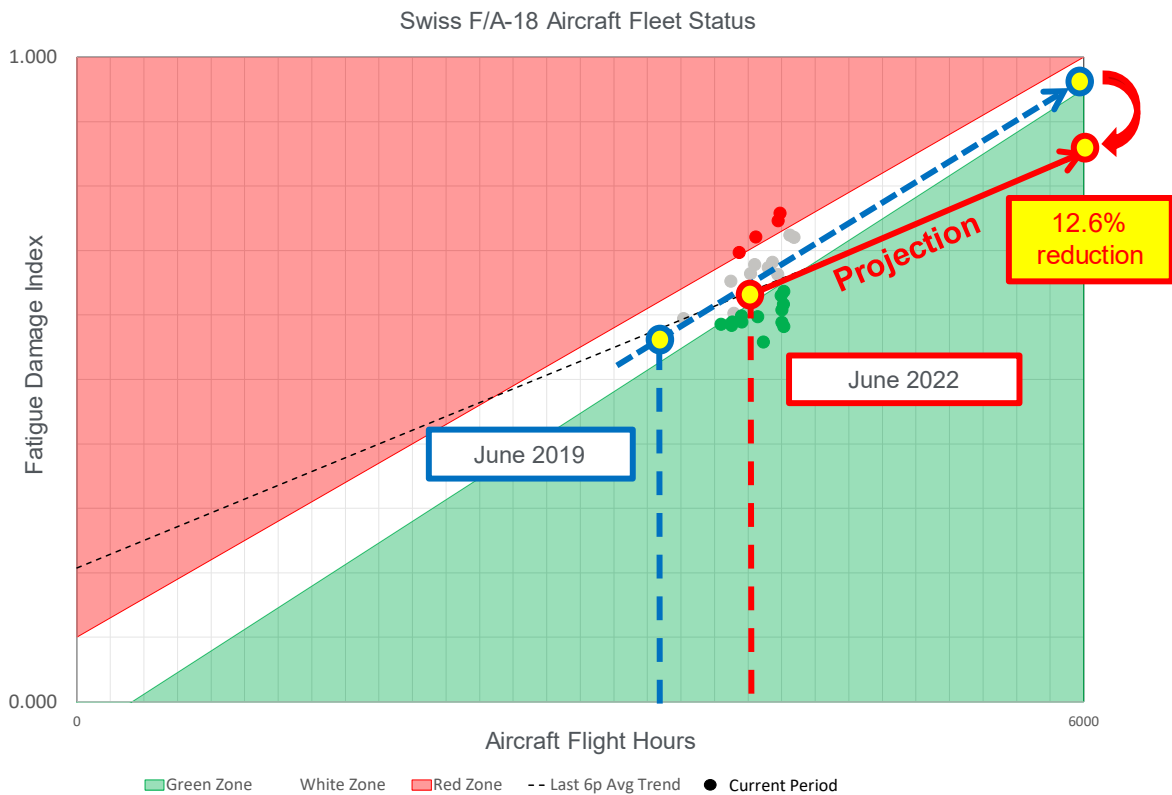
Figure 22

consumption rate has been recorded. The overall cumulative lifetime fatigue rate has dropped by 4.6% as well. And finally, the projected fatigue usage at the Design Service Goal (DSG) based on the last 3 years rate shows a potential overall reduction of 12.6%.

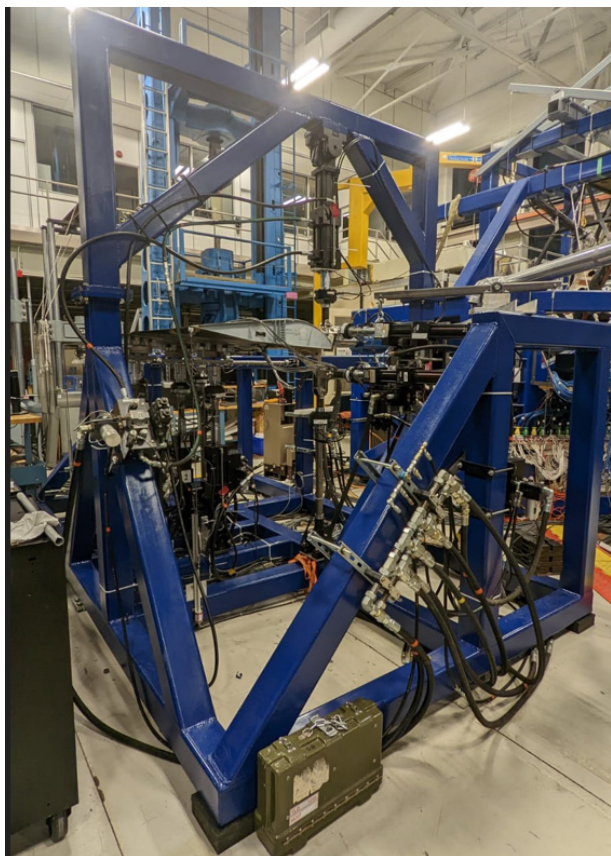
The Trailing Edge Flap Component Test is a durability and residual strength test, with the primary objective to validate the repair of the inboard hinge under the Swiss baseline fatigue spectrum. A secondary objective of the test is to collect additional data on fatigue damage in the remaining structure. The project was requested by the government of Switzerland, represented by armasuisse (Swiss Federal Council and the Federal Department of Defense, Civil Protection and Sports). RUAG AG (Switzerland) leads and technically supports the test which is performed by the National Research Council (NRC, Canada).

Figure 24: FTS4 – F/A-18 Trailing Edge Flap Component Test Rig

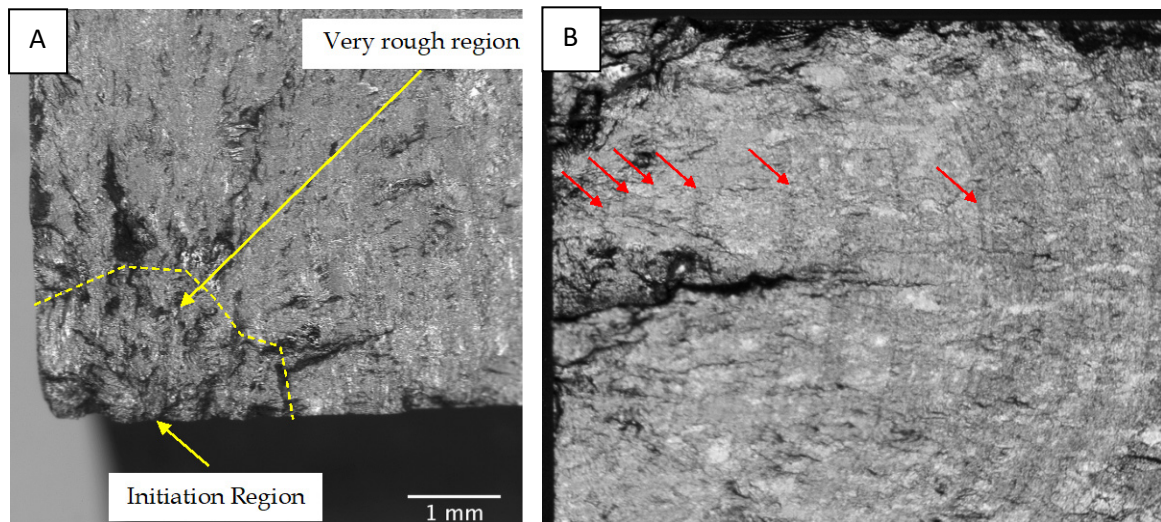
A fully reversed spectrum was used, and marker bands were added to support the evaluation of the crack growth rates, from small cracks until final failure. Due to the microstructure of the RA titanium material, creating reliably visible markers is significantly more challenging than in other materials such as aluminum. A detailed description of the marker development is presented in the ICAF 2023 paper: Kongshavn, I., Barter, S.A., Sorensen, L. (2023) *Measuring Small Fatigue Crack Growth with the Aid of Marker Bands in Recrystallized Annealed Ti6Al4V*, Proc. of the 31st ICAF Symposium.

Figure 25: Forged RA Ti6Al4V SENT coupons – A: Example of a fracture surface near the origin in RA Ti6Al4V and B: of some of the marker bands visible in the optical microscope.

By measuring the repeats of the marker bands, a crack growth curve was measured for each coupon using post-test quantitative fractography. Although there was a slight difference in the log-average CI lives measured between the truncated and untruncated spectra, based on the total lives to failure, the spectrum severity difference was marginal, which agrees well with the analytical prediction.

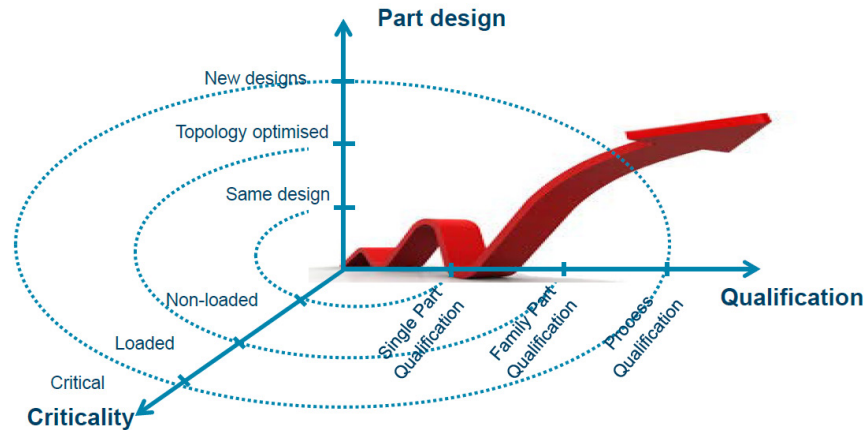
RUAG AG identified potential benefits for MRO activity and defined the goal of certifying the first additively manufactured part on the F/A-18, following the philosophy shown below and the EASA certification memorandum CM-S-008/3 – Additive Manufacturing.

Figure 29: Certification of AM parts. Source: Structures qualification and certification approach supporting AM introduction for system parts, AIRBUS, EASA-FAA Workshop Presentation, 2019.
