A REVIEW OF POLISH AERONAUTICAL FATIGUE AND STRUCTURAL INTEGRITY INVESTIGATIONS DURING MAY 2023 TO APRIL 2025

ICAF 2025

The 39th Conference and the 32nd Symposium of the International Committee on Aeronautical Fatigue and Structural Integrity, Xi'an, China, 9-13 June 2025

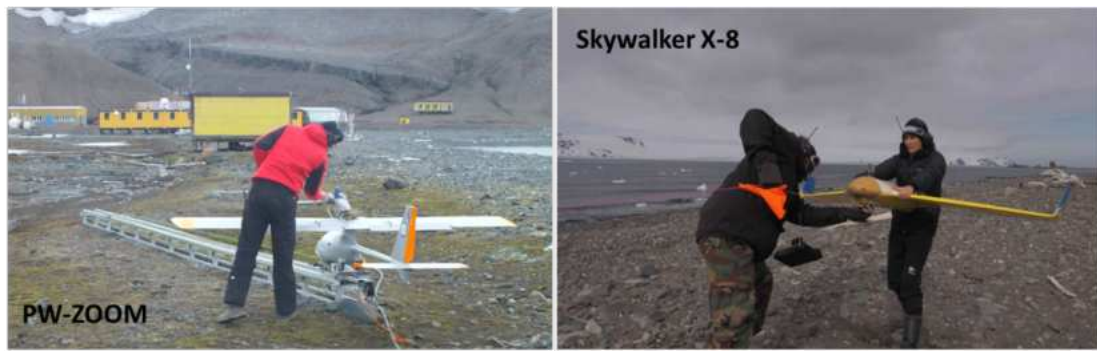
Fig. 1.1. Preparation to the take-off of PW-ZOOM (catapult) and Skywalker X8 (bungee)

One of the applications of unmanned aerial vehicles developed at the Warsaw University of Technology is photogrammetric missions. The team led by M. Rodzewicz has significant experience in this field. A notable achievement was the use of unmanned photogrammetric aircraft for monitoring ecosystems on King George Island in Antarctica. These studies were conducted as part of the MONICA project, funded by the Polish-Norwegian POL-NOR grant. The research utilized aircraft with a classic aerodynamic layout (PW-ZOOM) as well as flying wing aircraft (Skywalker X-8) (see Fig. 1.1). During the MONICA project, it was observed that the quality of orthophotos obtained from the photographs taken by both aircraft was significantly better for the PW-ZOOM, even though identical photogrammetric systems were used in both. It was hypothesized that the observed differences resulted from the distinct dynamic behaviors during flights in turbulent conditions, which were common during photogrammetric missions in Antarctica. The encountered turbulence disrupted the flight of the PW-ZOOM aircraft less than it did the Skywalker X-8, resulting in less blurred orthophotos during flights. It is worth noting that in both aircraft, the camera was rigidly mounted in the fuselage (without a gimbal to maintain a constant angular position).

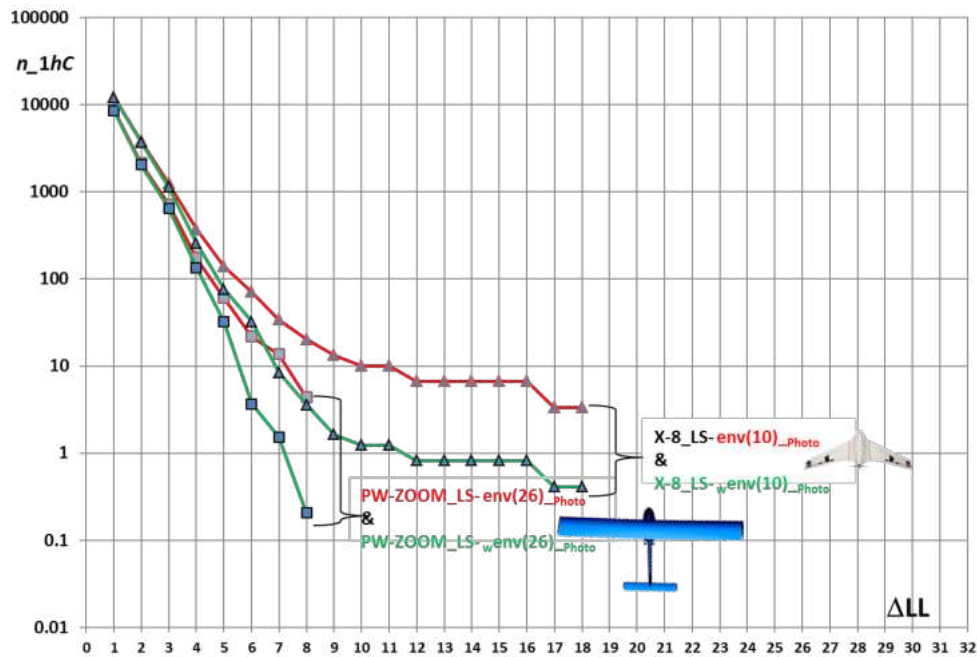
Fig. 1.3. The incremental load spectra (LS envelope and LS weighted envelope) for photogrammetric part of the flight mission.

Using load half-cycle arrays from multiple flights of each of the previously mentioned aircraft, single-branch incremental load spectra were generated. On the horizontal axis of such a spectrum, the ΔLL increment values are marked, while on the vertical axis, the cumulative number of load cycles (or cumulative number of load half-cycles) is indicated. The number for $\Delta LL = j$ is the sum of the cycle counts for each ΔLL value, starting from the highest value recorded in a given flight down to $\Delta LL = j$. The cycle counts occurring at each ΔLL level are referred to as level-specific load cycle numbers.

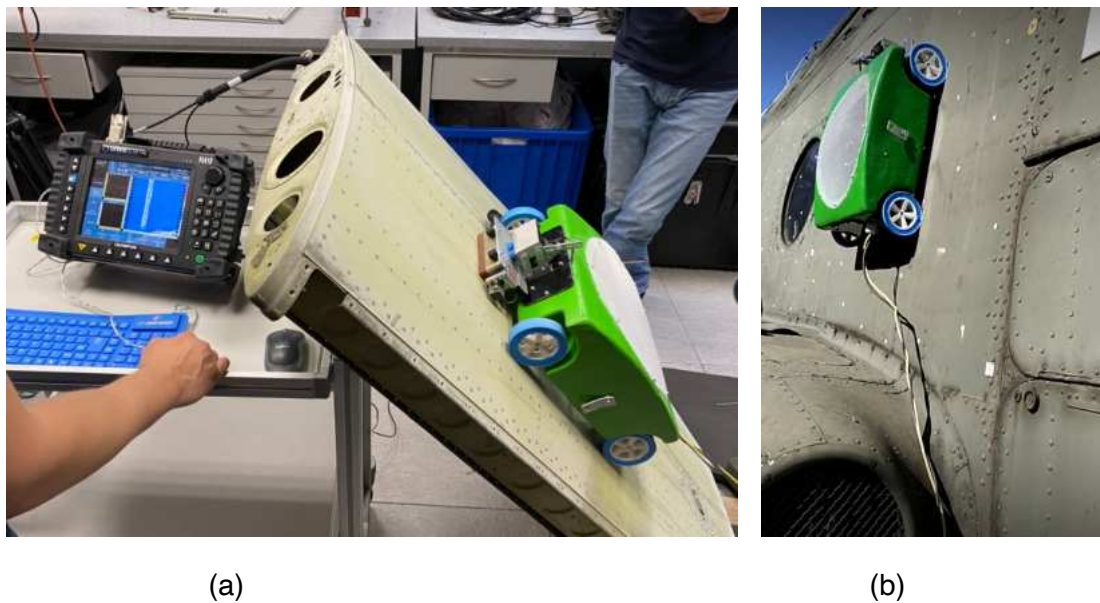
Fig. 2.5. Testing of the developed mobile robotic platform in laboratory conditions and on the fuselage of a military helicopter.

Furthermore, common activities of the Structural Integrity Assessment Research Group of the Silesian University of Technology and the Division of Airworthiness of the Air Force Institute of Technology resulted in development mobile robotic platform to automate NDT inspections. The developed robotized mobile platform equipped with eddy current probes for aircraft inspections was described in [7]. This system enhances efficiency by automating labor-intensive scanning processes and reducing human error. The use of robotic systems in NDT inspections significantly accelerates data collection and enhances consistency in damage detection. It is expected that automated inspection systems can reduce inspection times by up to 40% while maintaining high detection accuracy.

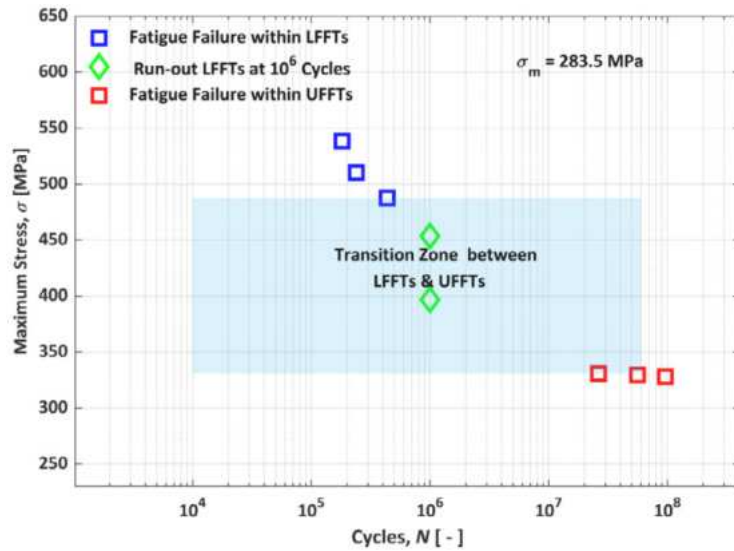
Fig. 2.8. A combination of low-frequency and ultrasonic-frequency fatigue responses for CF/PEKK thermoplastic composite indicating the transition zone between traditional and accelerated fatigue testing techniques [14].

Common studies with the University of Freiburg were focused on fatigue strength estimation of CF/PEKK composites through self-heating temperature analysis using high-frequency cyclic bending tests [13,14]. It was demonstrated that fatigue strength can be reliably estimated through temperature evolution patterns, providing a rapid and efficient alternative to traditional fatigue life assessment methods. This research also highlighted the significance of distinguishing between stationary and non-stationary self-heating regimes, as the latter leads to accelerated degradation and thermal fatigue failure. Further, we expanded on these findings by investigating thermomechanical fatigue behavior of CF/PEKK composites under low and ultrasonic frequencies. This study combined experimental approaches to construct S-N curves for different loading regimes, revealing that heat dissipation rate can serve as a linking parameter between low-frequency and high-frequency fatigue tests. Fractography confirmed similarities in fatigue damage mechanisms across different loading conditions, supporting the feasibility of cross-regime fatigue life predictions.

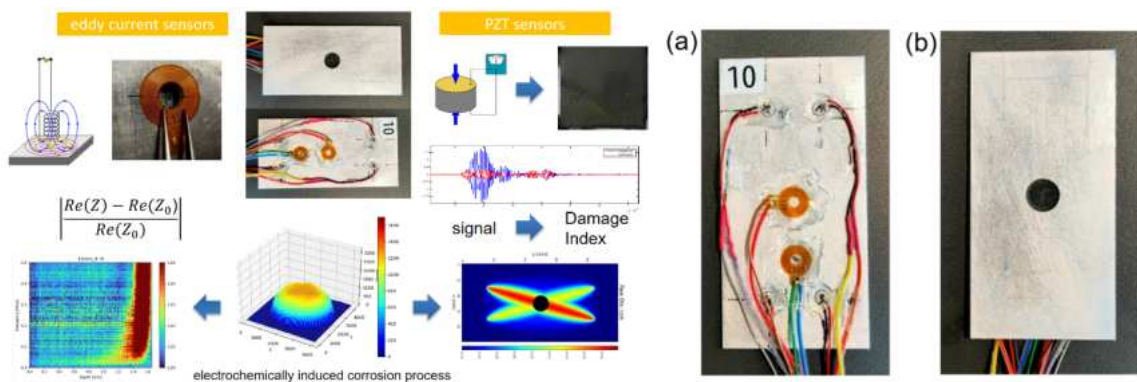
Figure 3.1. Corrosion monitoring techniques evaluation based on PZT and ECS sensors

Polish side activities are mainly devoted to verification of selected corrosion, load and damage monitoring sensor technologies due to extract relevant damage features from sensors' signal and to provide both the actual healthy condition of the helicopter components as well as to detect the damage progression. On ground research tasks for corrosion consisted of conducting corrosion damage growth tests using piezoelectric and eddy current sensors in the defect monitoring process. The development of the corrosion defect was performed in an electrochemical process (Figure 3.1).

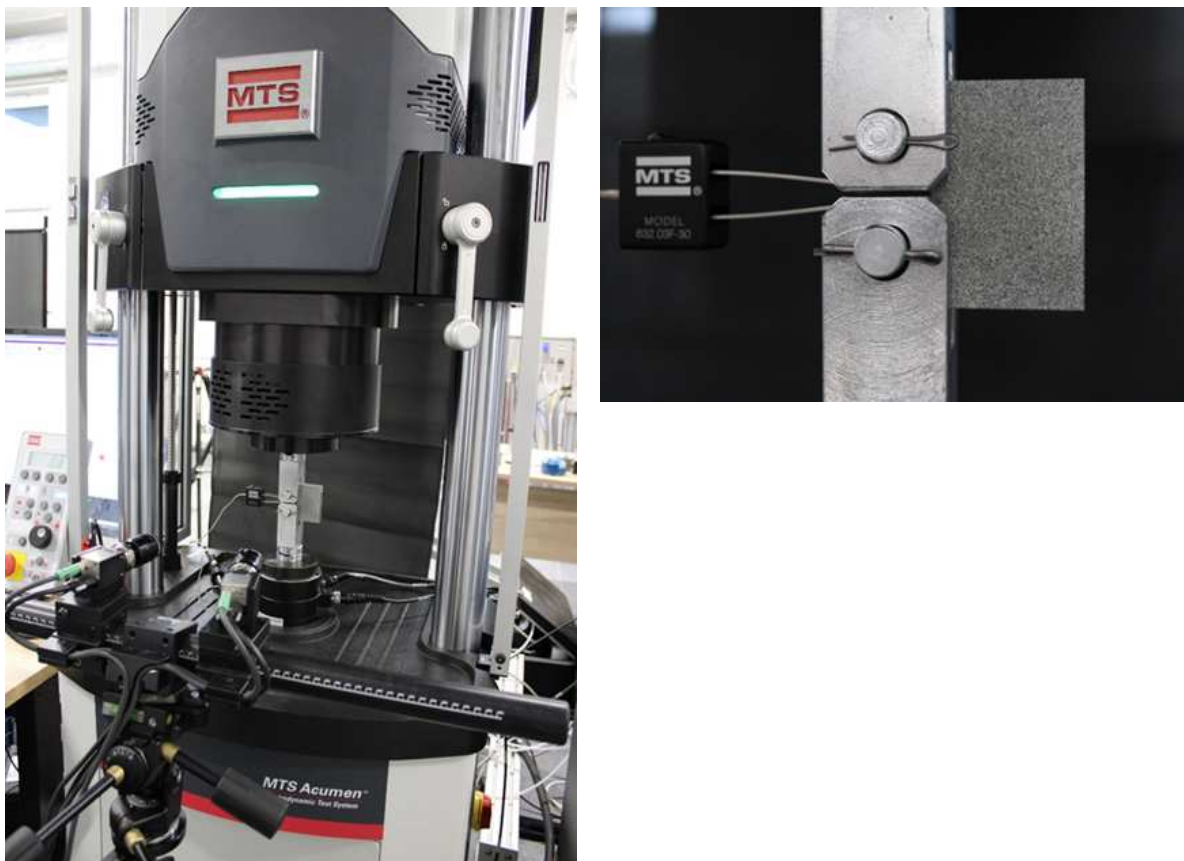
Figure 4.3. Test specimen placed in the test stand. During (with a COD gauge) and after the test

- W – characteristic dimension of each CT sample measured from the pin holes center to the rear of the sample,
- B – thickness of each specimen,
- E – Young's modulus – defined during the precracking stage,
- P – load force applied by the machine,
- u – crack displacement measured with a COD gauge (Fig. 4.3).

Each test was carried out using a different load sequence until the defined test limits were achieved, which were defined as the maximum displacement of the machine piston under the current load. The maximum load in each load sequence was around 4kN and it appeared several times throughout one sequence pass. Whenever this load caused the piston displacement to exceed the set value, the test halted and the specimen was considered fractured.

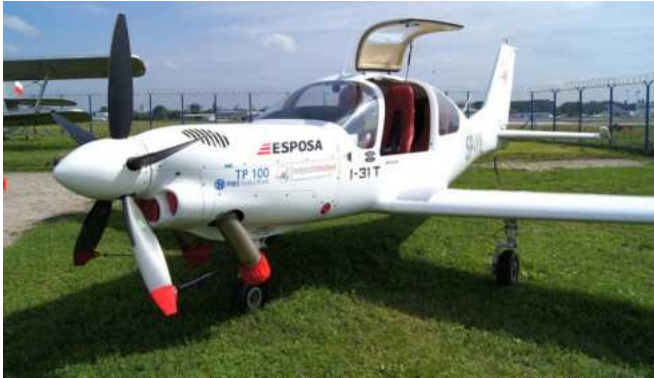
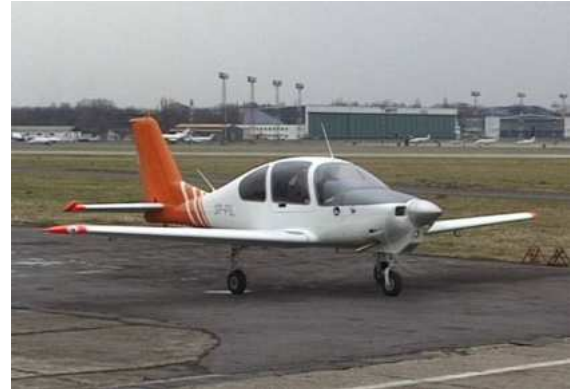
Figure 5.1. I-31P (left) and I-23 (right) airplane. *Source: L-ILot.*

The I-31 aircraft ((Fig. 5.1. - left) is redesigned version of the I-23 airplane ((Fig. 5.1. -right) - no major changes to design of its landing gears were made. There were changes made to some of the materials and manufacturing technologies.

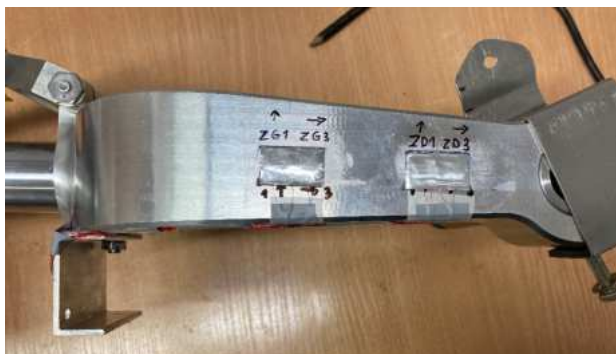
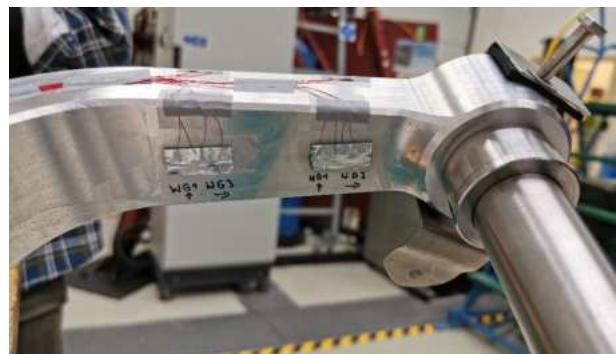
Figure 5.2. Strain gauge placement on NLG half-fork. *Source:* L-ILot.

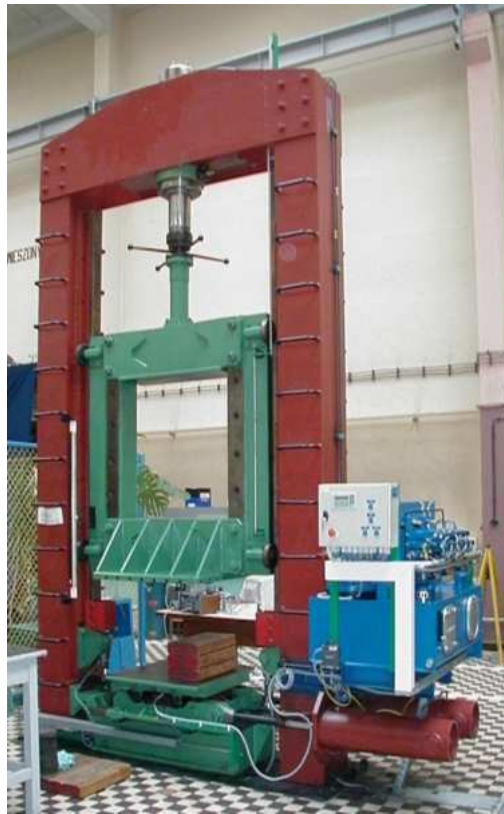
Figure 5.4. 40/20T Press. *Source:* Landing Gear Laboratory, L-ILot.

Two sets of static characteristics were made in order to achieve the load envelope for the shock absorber parameters. Two separate fillings/charging of the shock absorber were made using the concept to use the same parameters and techniques for every shock absorber filling/charging. Static tests were also separated by the dynamic tests for each filling/charging.

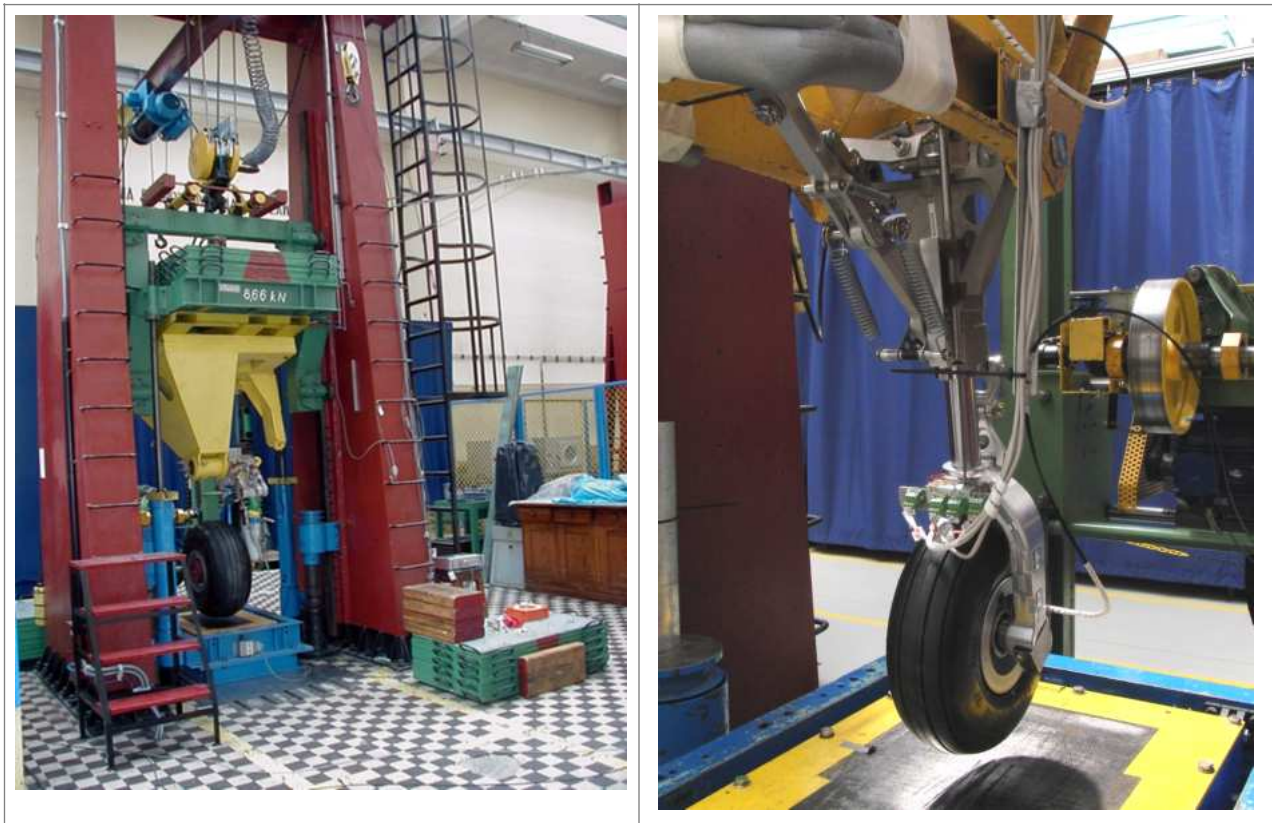
Figure 5.7. M10T test stand – overview example (left), I-31 NLG mounted (right).
Source: L-ILot.

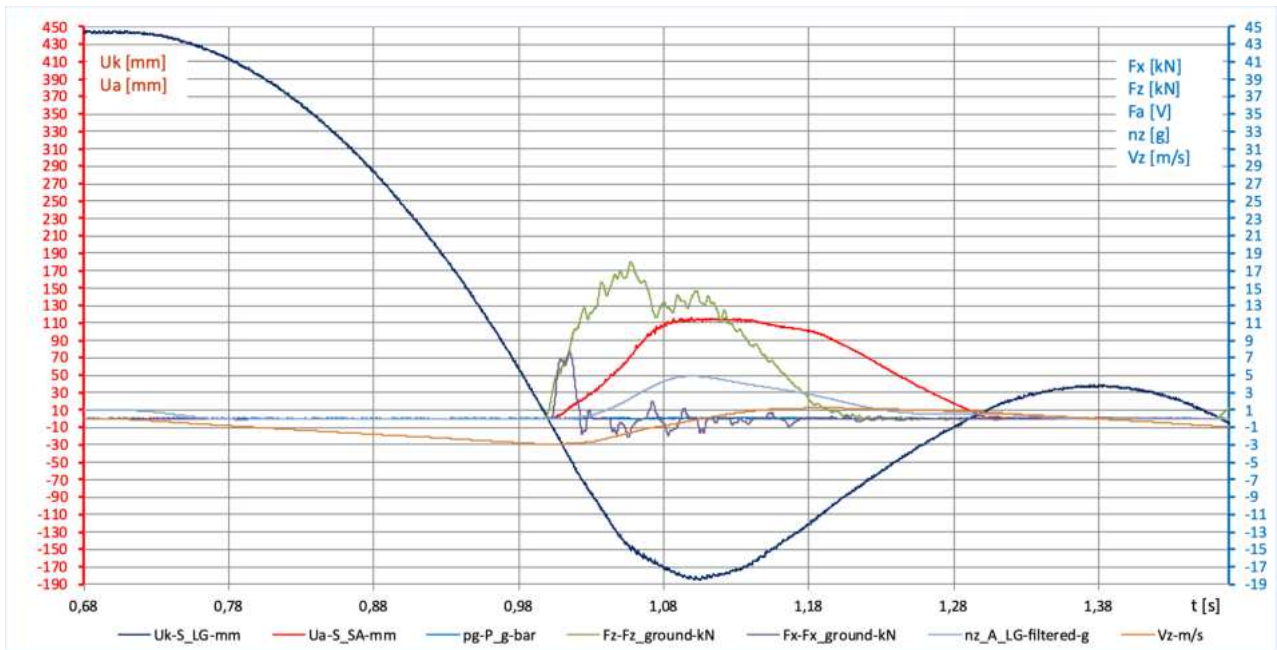
Figure 5.10. Example of full-scale dynamic I-31P NLG drop tests, general results. 2nd filling/charging, 0326-dt-NLGI31-M10T-094. *Source:* L-IILot

As in the case of static tests, drop tests were performed in two sets for different fillings/chargings. Test results are presented in the Figures 5.8 to 5.11.

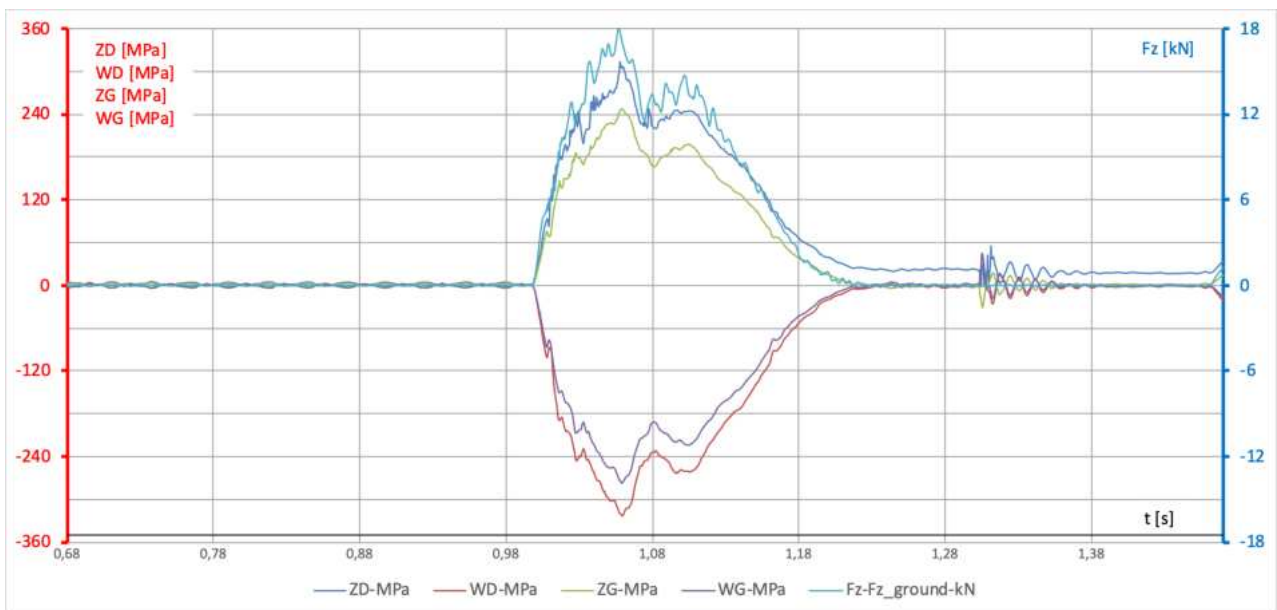
Figure 5.11. Example of full-scale dynamic I-31P NLG drop tests, strain gauge results. 2nd filling/charging, 0326-dt-NLGI31-M10T-094. *Source:* L-IILot

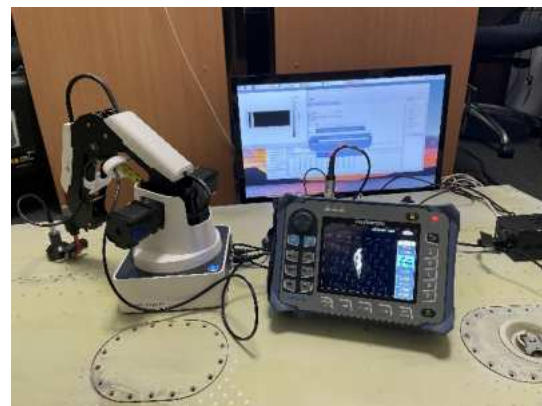
Figure 6.2 System assembly

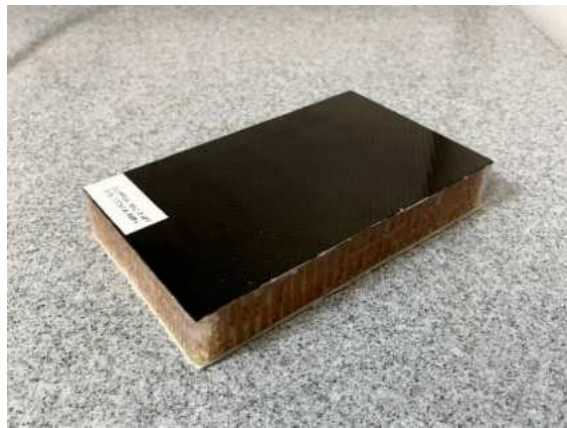
Figure 6.3. Sample 1. (used for MIA testing)

- Such kind of structures are widely used in the aerospace industry since they are a combination of high stiffness and low mass [13].

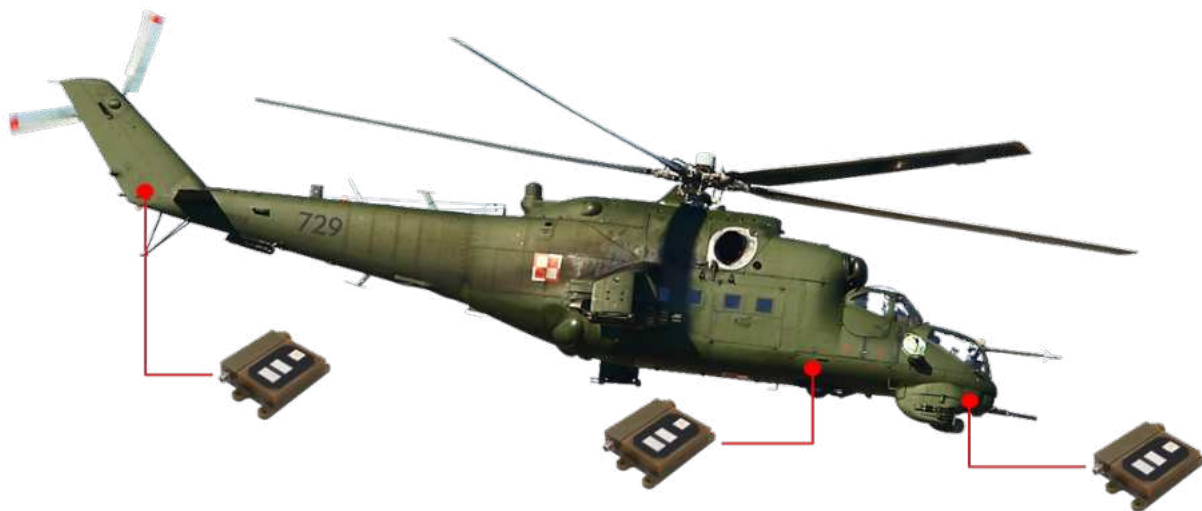
Figure 7.1. CHM system consisting of three autonomous sensors installed on in-service Mi-24

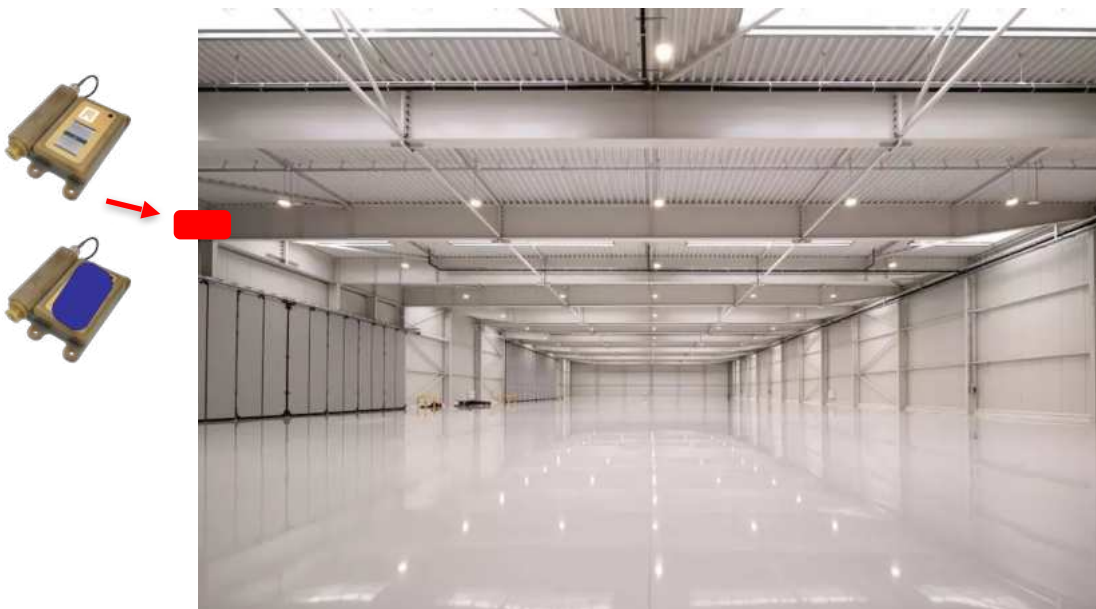
Figure 7.2. Example location of corrosion sensors on the hangar structure

Implementing a CHM system can significantly enhance the assurance of structural integrity through the deployment of appropriate sensors. These sensors facilitate continuous monitoring and early detection of potential issues, particularly corrosion, thereby aiding in timely maintenance and prevention of structural failures. For instance, installing an Acuity LS sensor kit on the structural beams of a hangar roof (Fig. 7.2), where corrosion is most likely to occur (Tzortzinis et al., 2020a), utilizing both painted and bare sensors, allows for a comprehensive assessment of the environmental conditions affecting the structure (Tzortzinis et al., 2020a, 2020b). This configuration enables the evaluation of the current state of the structure and the identification of potential future corrosion-related threats. By monitoring using corrosion sensors both coated and uncoated surfaces, the system can provide valuable data on the onset and progression of corrosion, facilitating proactive maintenance and ensuring structural integrity.

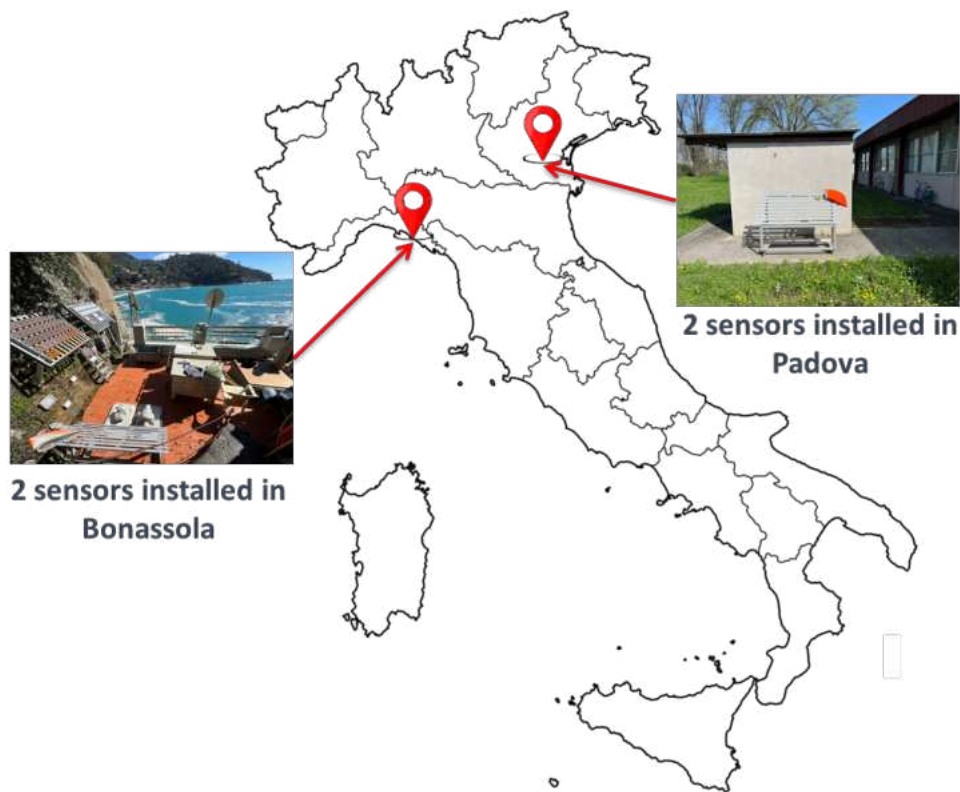
Figure 7.3. Two atmospheric corrosion test sites in Italy (CNR-ICMATE laboratories in Padua and Bonassola)

To test the effectiveness of the CHM systems, two different locations in Italy were selected as corrosion test sites: the CNR-ICMATE facilities in Padua and Bonassola (MARECO Laboratory), shown in Fig. 7.3.

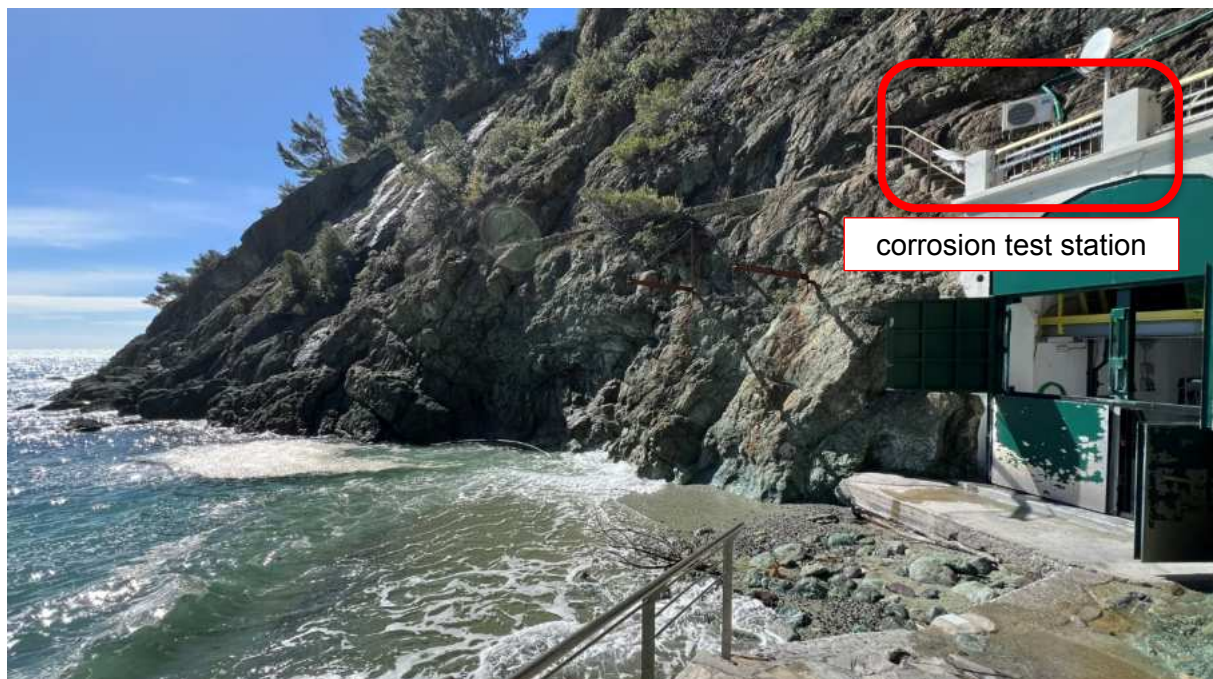
Figure 7.4. View of the corrosion test station in Bonassola

The test site in Bonassola, a small village on the Ligurian coast of the Mediterranean Sea, is a sea-exposed site at MARECO, the CNR-ICMATE polythematic marine laboratory (Fig. 7.4). Here, a stand with sensors is placed on the balcony above a laboratory set inside a cave. During fall 2023, a severe storm induced particularly high surf, with waves causing intense washing of the Acuity LS position. In Padua the corrosion test site is located in an industrial zone, in the immediate vicinity of the highway (city bypass) and two large railway reloading facilities (Fig. 7.5). It is one of the most industrialized regions of northern Italy. These locations provide data from environments where aircraft and potential airport installations are most exposed to rapid corrosion.

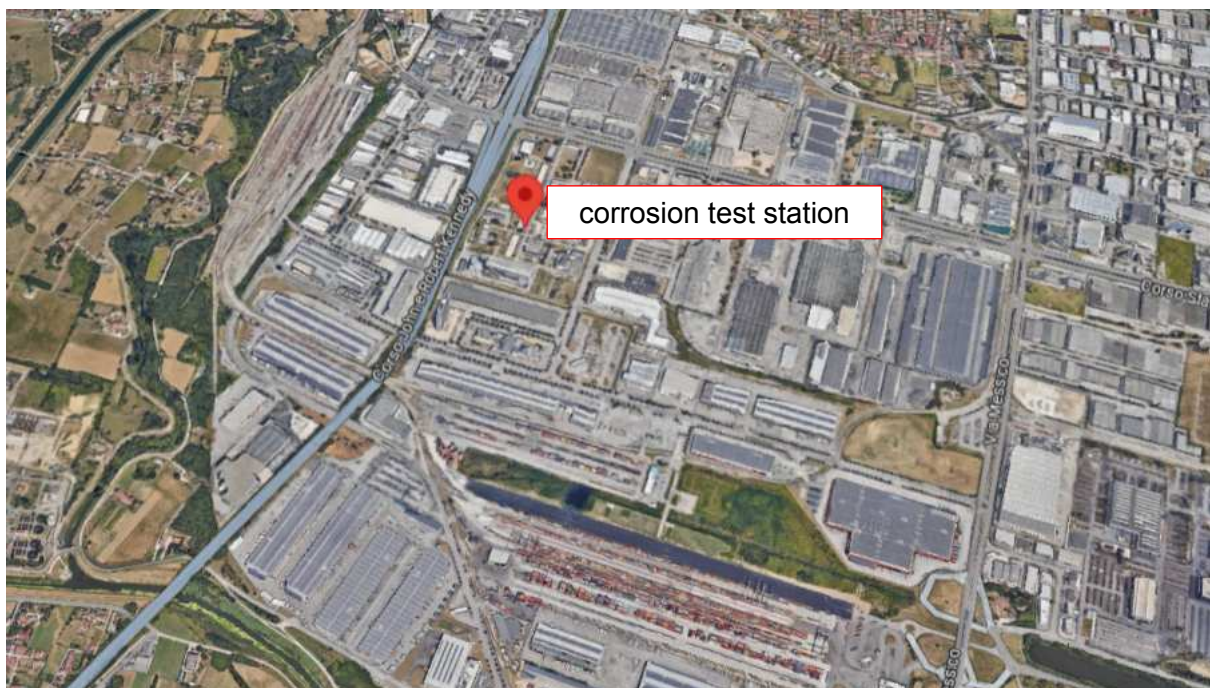
Figure 7.5. View of the corrosion test station in Padua (Google view)

Sensors at both corrosion test sites were positioned similarly: one sensor was installed in an open-air environment, while the other was positioned inside an aircraft wingtip (simulating the microclimatic conditions within a confined space). An autonomous sensor array with an independent power supply, the Acuity LS (Fig. 7.6) from Luna Labs, was selected for this study (Friedersdorf et al., 2019). This choice was primarily influenced by the prior successful implementation of these sensors by AFIT in a flying helicopter in recent years, demonstrating their reliability and suitability for similar applications.
