# A New Approach to Accidental Damage on Aircraft Metallic Structure

31<sup>st</sup> ICAF Symposium - Delft, 26-29 June 2023

**AIRBUS**

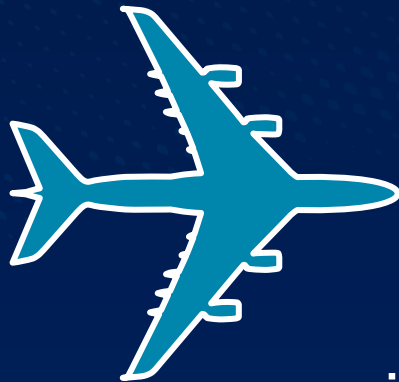
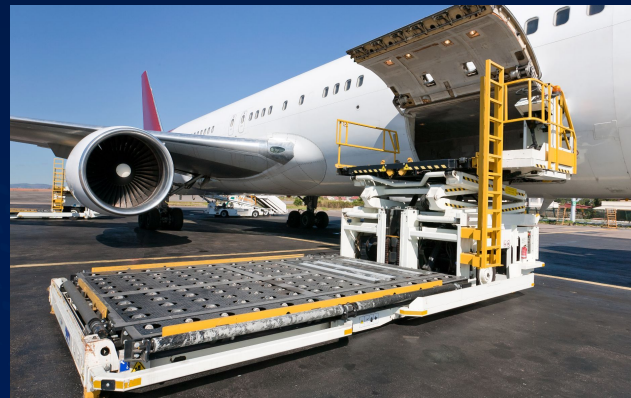
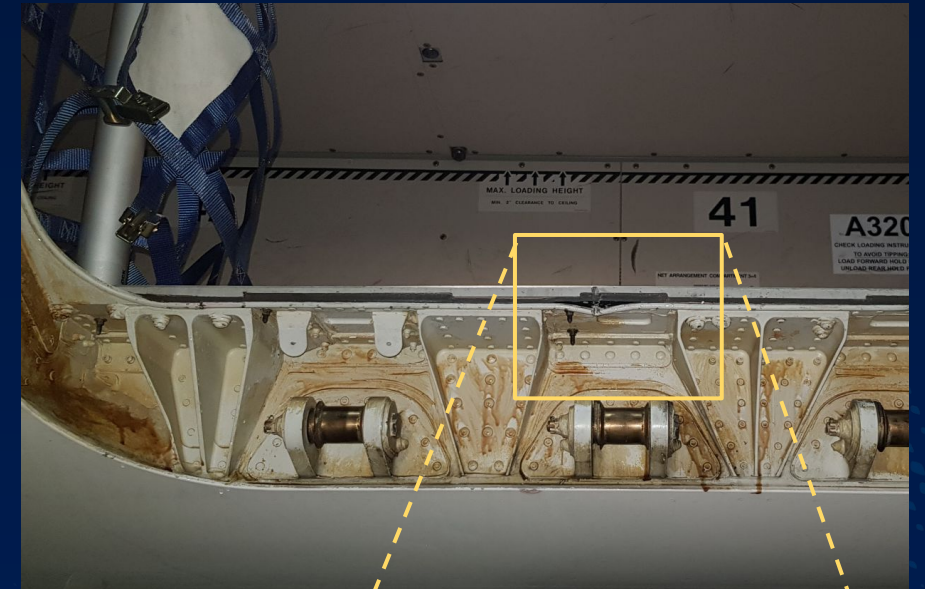
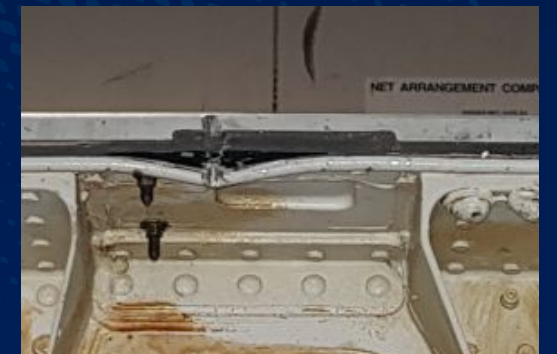
Impact by ground & cargo handling equipment

Impact by foreign objects (tools, vehicles)

Runways debris

Hail strikes

Human error

... in production, operation and maintenance

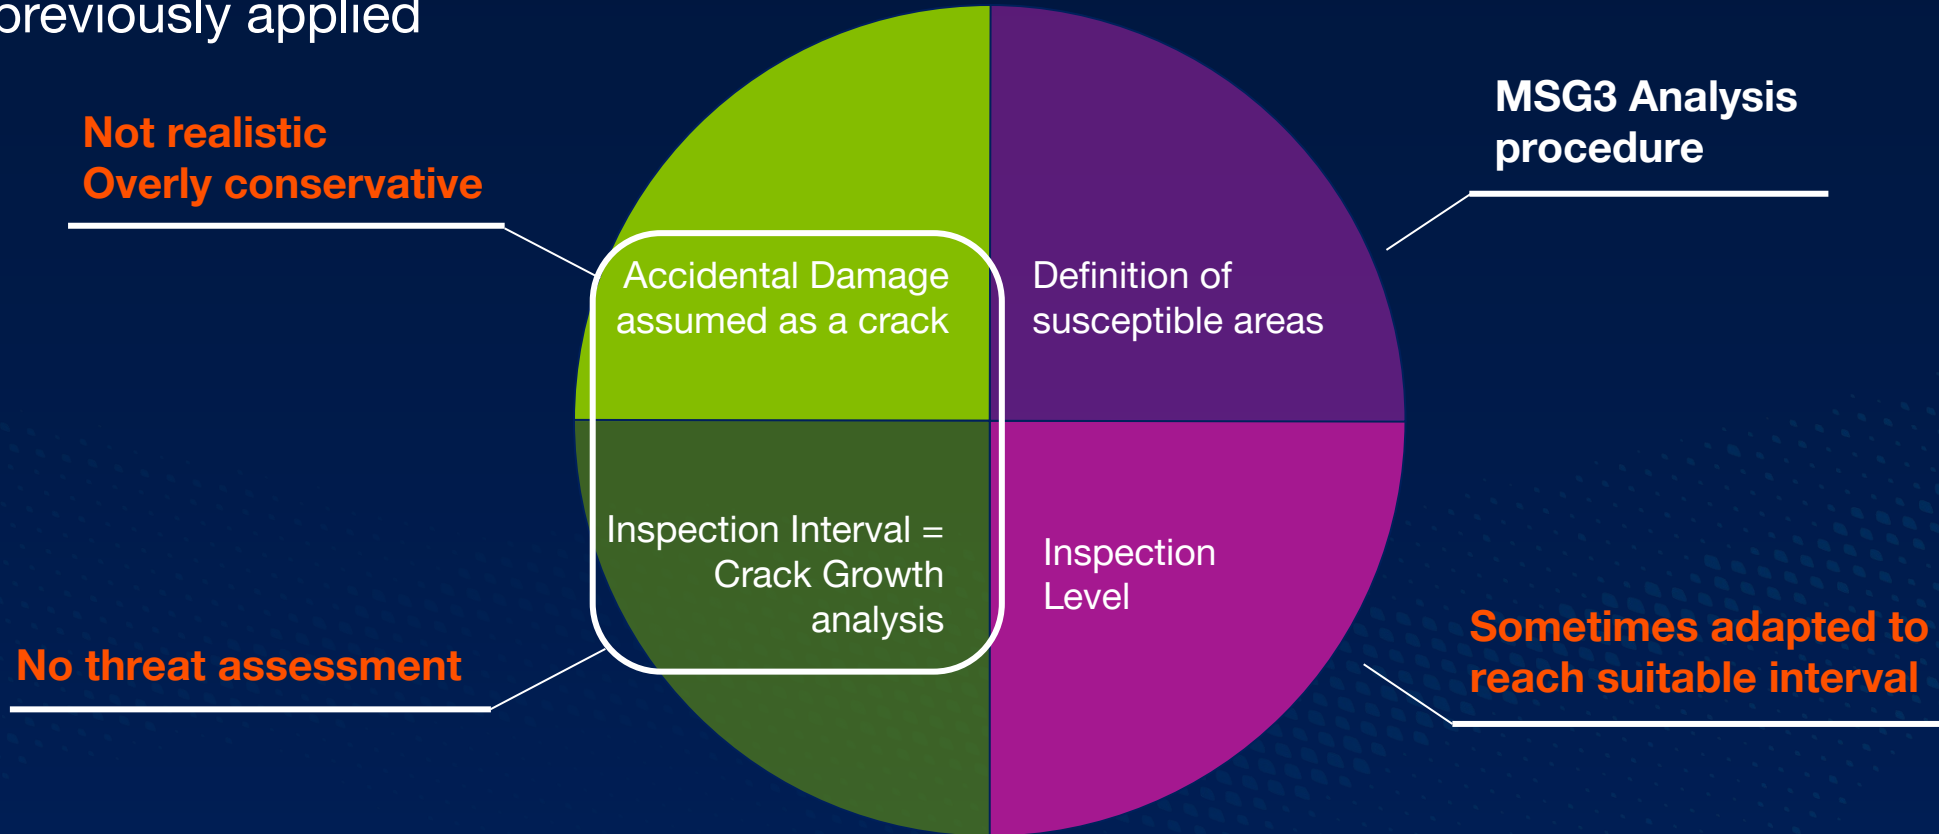
Approach previously applied

Time to define a more effective, more realistic approach  
Take credit of 50 years of test & service experience

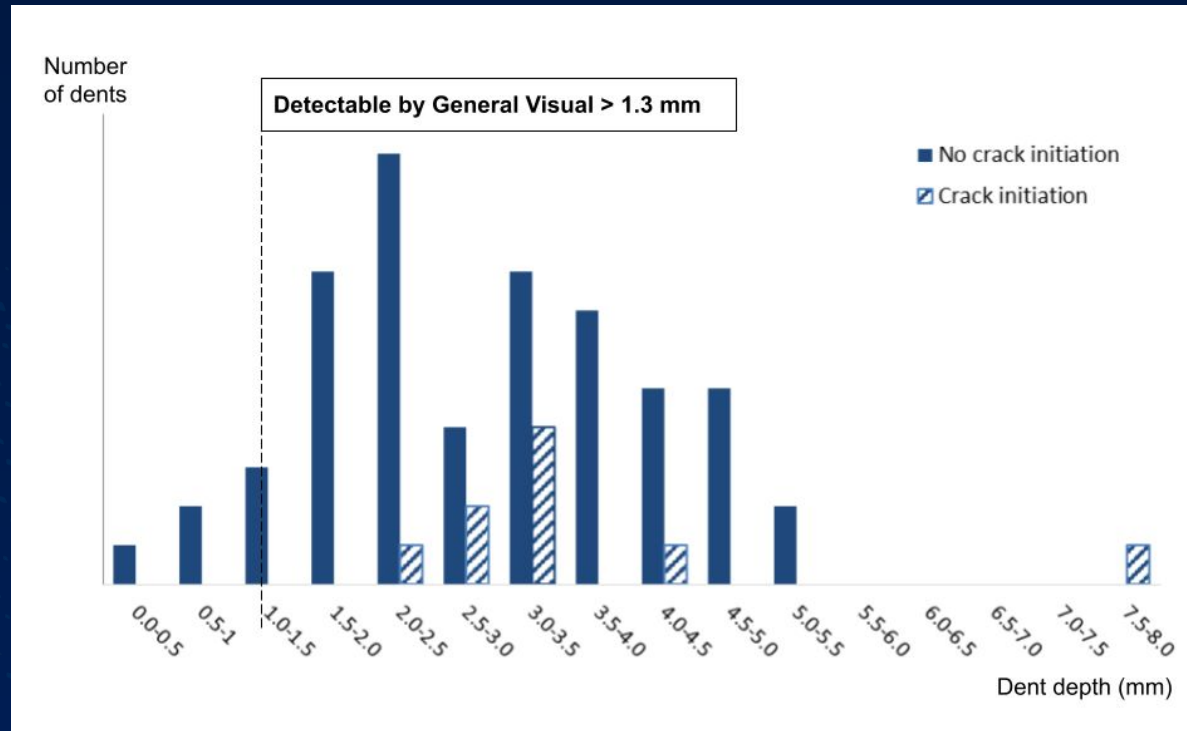
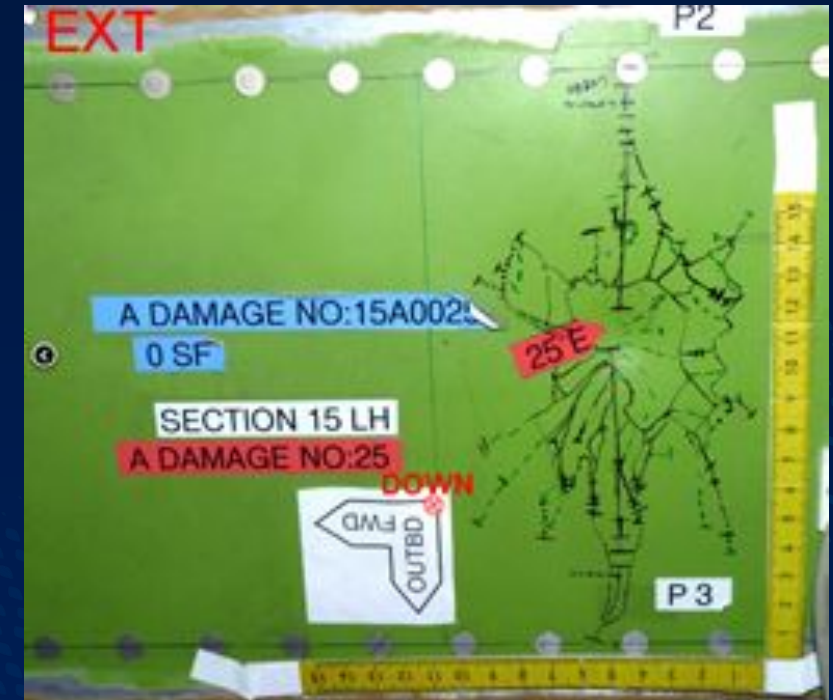
- More than 100 dents applied and tested on AIRBUS Full-Scale Fatigue specimens

- No crack initiation from dents with a depth lower than 2.3 mm
- Dents deeper than 1.3 mm can be detected with a General Visual Inspection

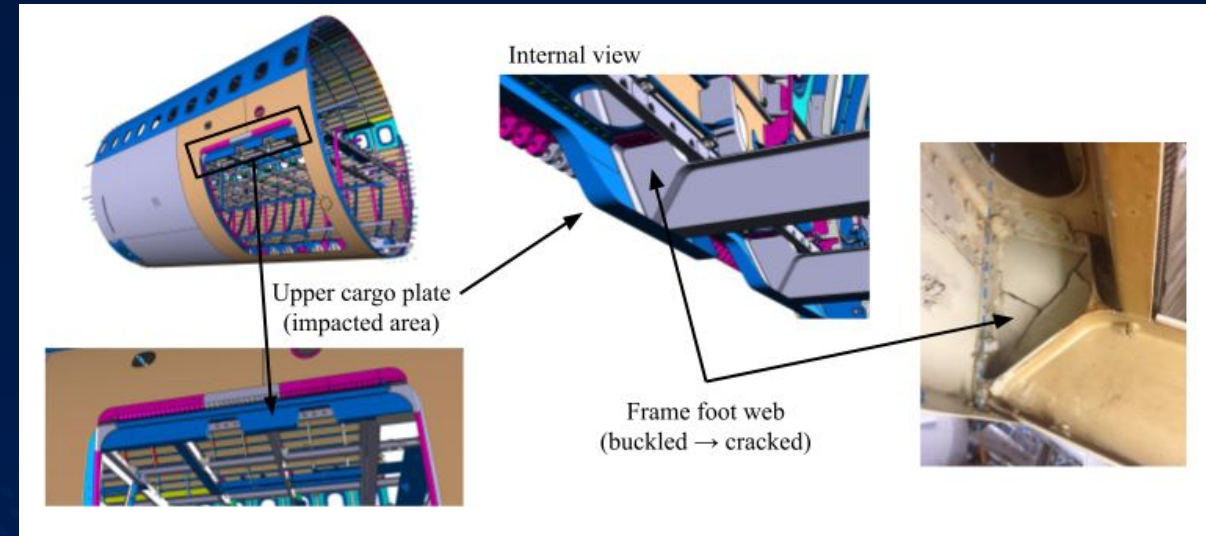
- Several thousands of damage reports from AIRBUS databases reviewed

- Accidental damage was found well before significant interaction with fatigue damage

Fatigue crack initiated from accidental damage before this accidental damage is found → UNLIKELY

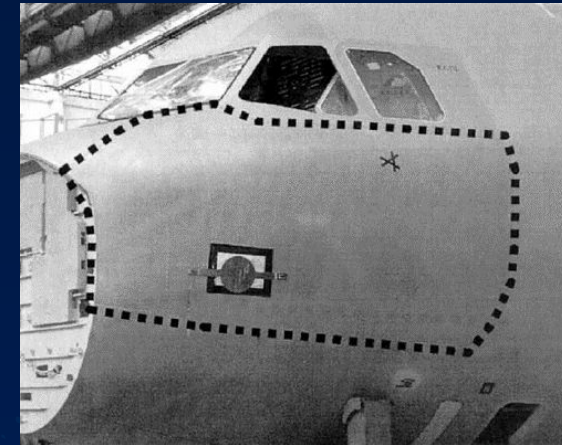
Application example: A320 Fuselage side panel below cockpit window

... based on a **rating system**

ACCIDENTAL DAMAGE RATING	
		1	2
STRESS SENSITIVITY	0 - Very Low	No task required	12 YE
	1 - Low	12 YE	6 YE
	2 - Medium	6 YE	3 YE
	3 - High	3 YE	Specific justification

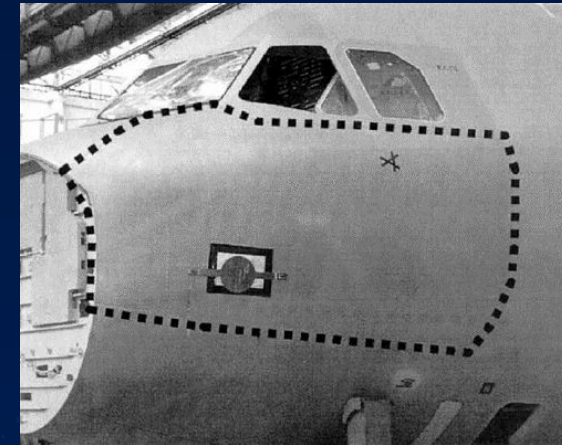
Application example: A320 Fuselage side panel below cockpit window

General Visual Inspection

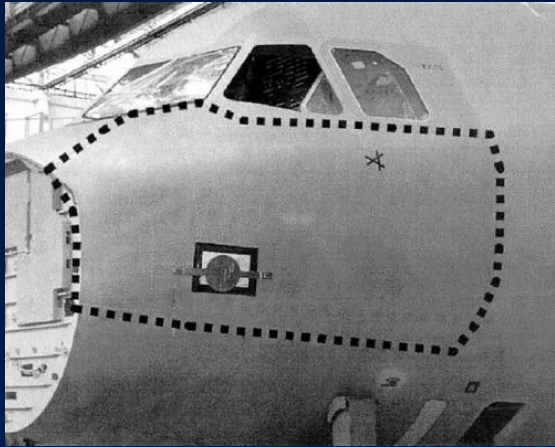
Application example: A320 Fuselage side panel below cockpit window

Threat assessment

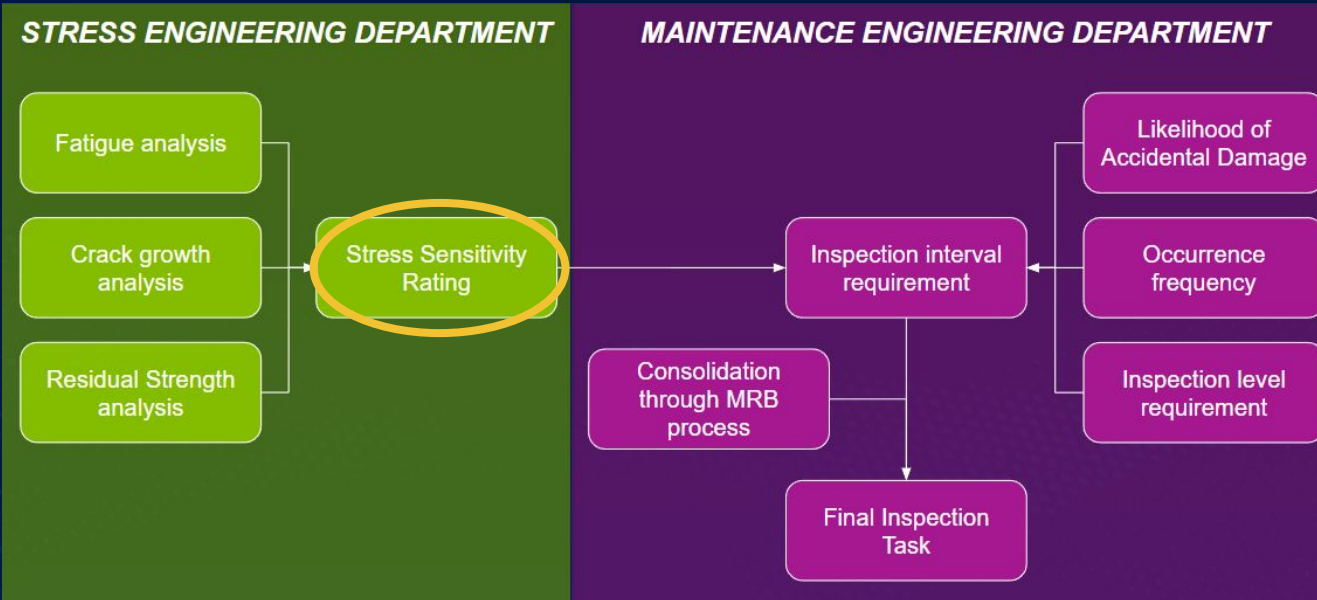
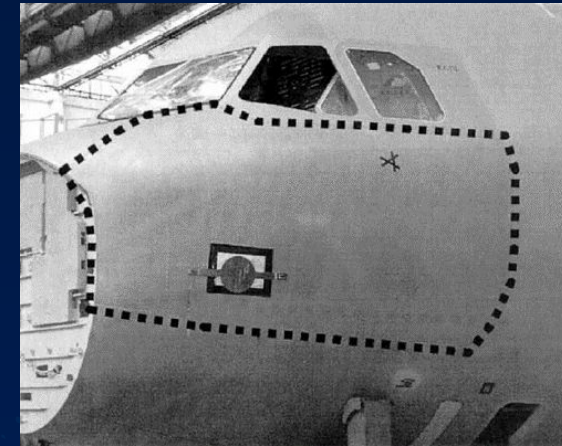
Application example: A320 Fuselage side panel below cockpit window

**Qualitative** assessment of Fatigue & Damage Tolerance behaviour

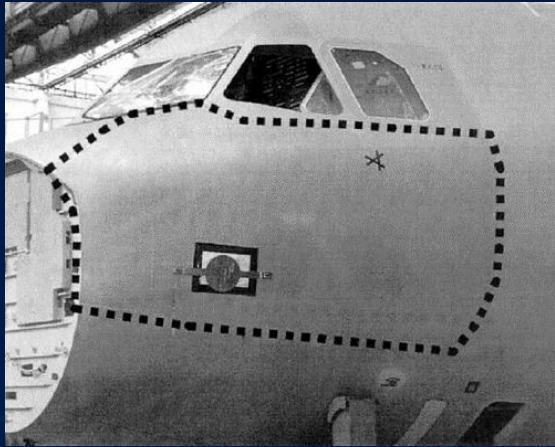
Application example: A320 Fuselage side panel below cockpit window

General Visual Inspection

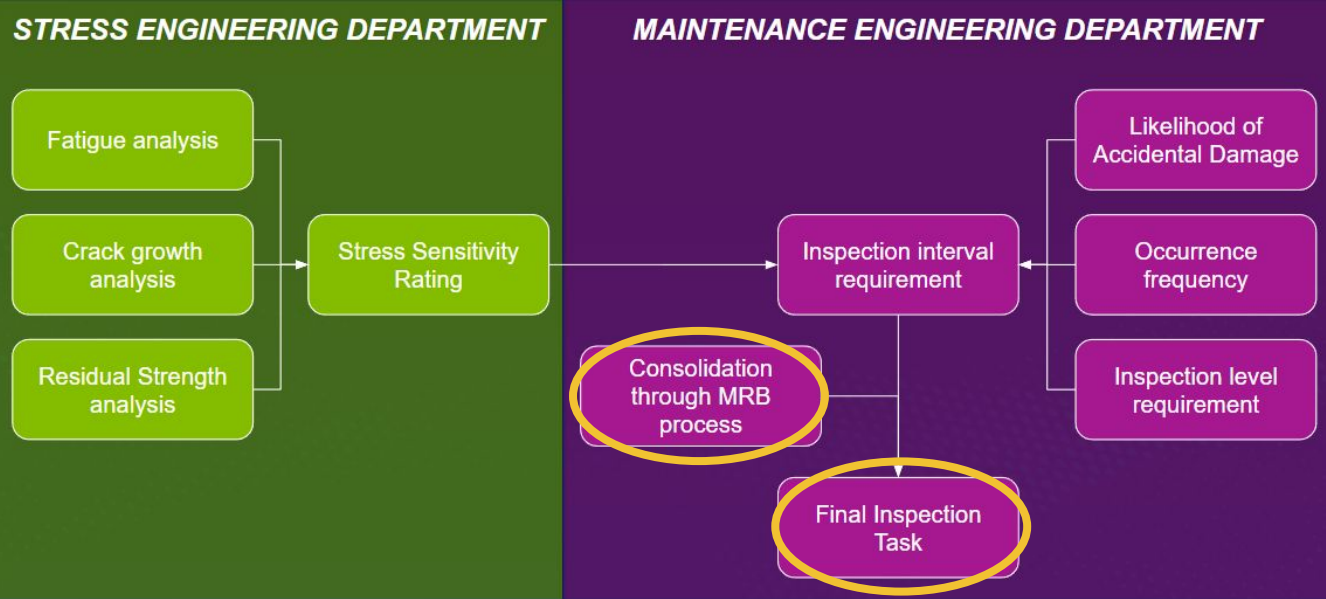
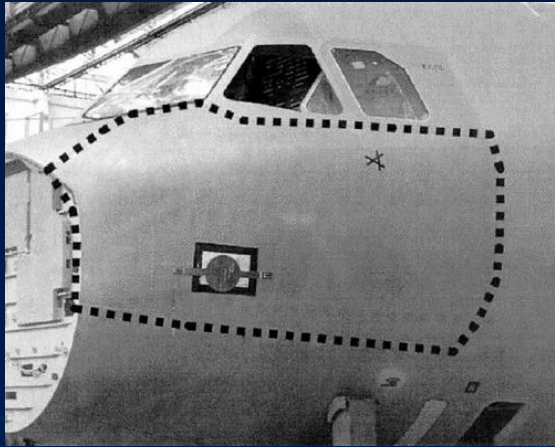
Application example: A320 Fuselage side panel below cockpit window

Existing zonal task (interval 48 months) adequately covers the area
