**REVIEW OF AERONAUTICAL FATIGUE
INVESTIGATIONS IN JAPAN
DURING THE PERIOD JUNE 2023 TO MAY 2025**

Takao Okada
Japan Aerospace Exploration Agency

For Presentation at the 39th Conference of
the International Committee on Aeronautical Fatigue and Structural Integrity

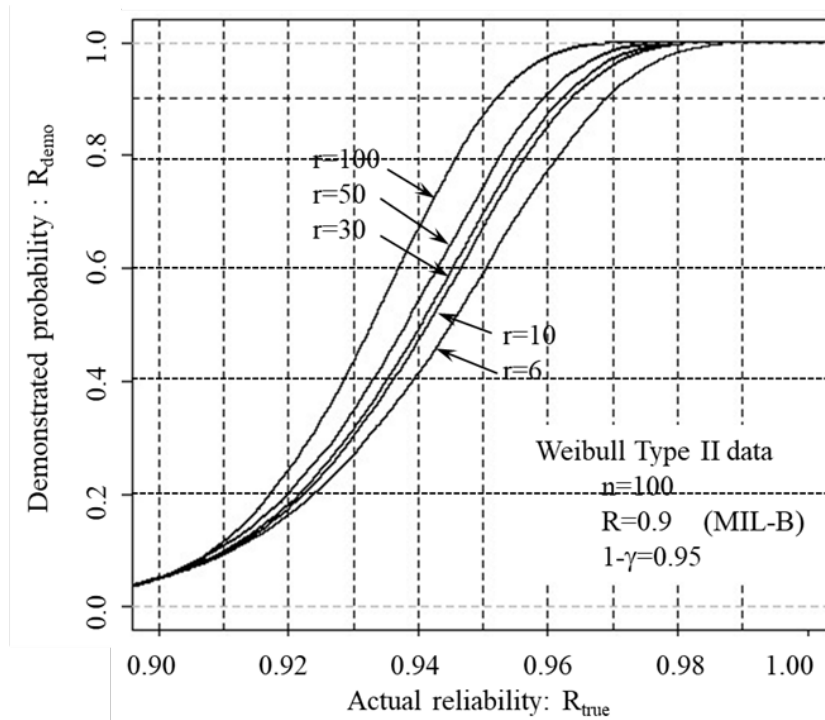
Figure 2.2.2 Demonstrated probability for Weibull Type II data

When the strength distribution is assumed to follow a normal distribution, the exact form of the distribution F_{x_L} can be derived. However, for other distributions, such closed-form solutions are not available, and the lower bounds and their associated true reliabilities must be estimated using Monte Carlo (MC) simulations. As a case study, we consider the calculation of the strength demonstration probability of a two-parameter Weibull distribution $W(x|a,b)$ using Type II censored samples obtained by assuming the true values. After transforming the variables to the extreme value domain, we estimate the Weibull parameters via maximum likelihood estimation (MLE), and similarly to the normal distribution, compute the coefficient of variation for interval estimation. Subsequently, MC simulations are performed to evaluate the lower bounds. Under the MIL-B conditions of a target reliability $R = 0.9$ and confidence level $1-g = 0.95$, the simulation provides empirical distributions of both the actual reliability and the lower bound (Figure 2.2.2). For a fixed sample size of $n = 100$, and varying numbers of censored failures $r = 6, 10, 30, 50, 100$, if the actual reliability is set to $R_{\text{true}}(x_L^*) = 0.96$, the demonstrated probability R_{demo} increases as r increases. For instance, when $r = 50$, the demonstrated probability reaches $R_{\text{demo}}(x_L^*) = 0.9$, indicating that the demonstration test has a 90% probability of success. This outcome is attributed to the increased

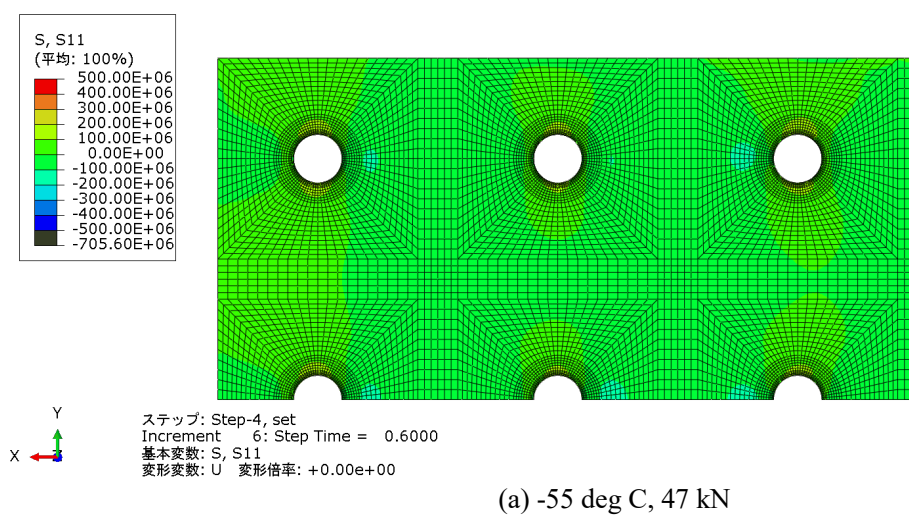
Figure 2.3.2 S11 (Sxx) contour at z=2.28mm on Aluminum plate

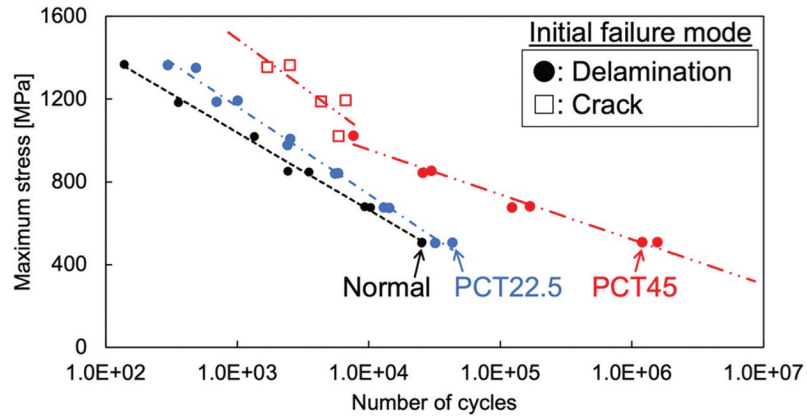
Fig. 3.1.2 Number of cycles to final failure. PCT45, with the largest PCT angle of 45°, has the largest failure cycle, and delamination from the ply edge is the initial damage that maximizes the effectiveness of PCT.

Ply drop-off is a weak point of a tapered composite laminate, where stress concentration occurs and delamination initiates. By suppressing delamination from the ply drop-off, more optimized structural design and further weight reduction are possible. The authors' research group has been proposing Ply Curving Termination (PCT), which locally changes the fiber direction at the edge of the dropped ply (Fig. 3.1.1), to suppress delamination from the ply edge [1]. This study conducted tensile fatigue tests using asymmetric taper configuration. Damage initiation, delamination propagation, and final failure were evaluated in detail by changing the PCT fiber angle (Fig. 3.1.1) and loading level. The results confirmed that large PCT angles are effective in improving the fatigue properties of tapered laminates and that controlling the location of initial damage is necessary to maximize the effectiveness of PCT (Fig. 3.1.2). Based on the findings, an effective design guideline for tapered laminates with PCT can be discussed.

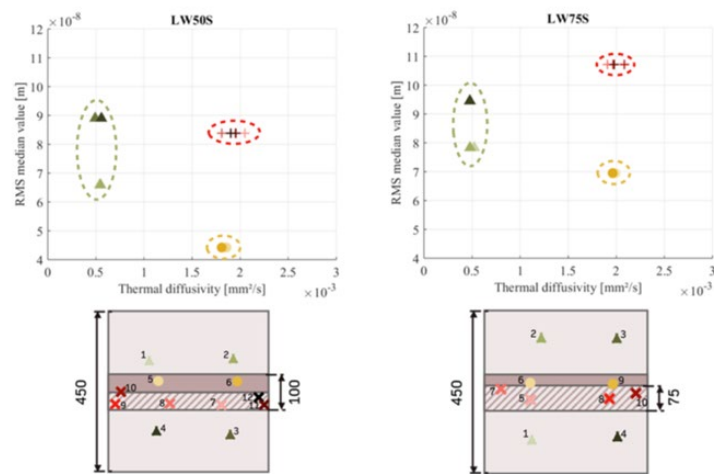
Figure 4.1.2 Test results

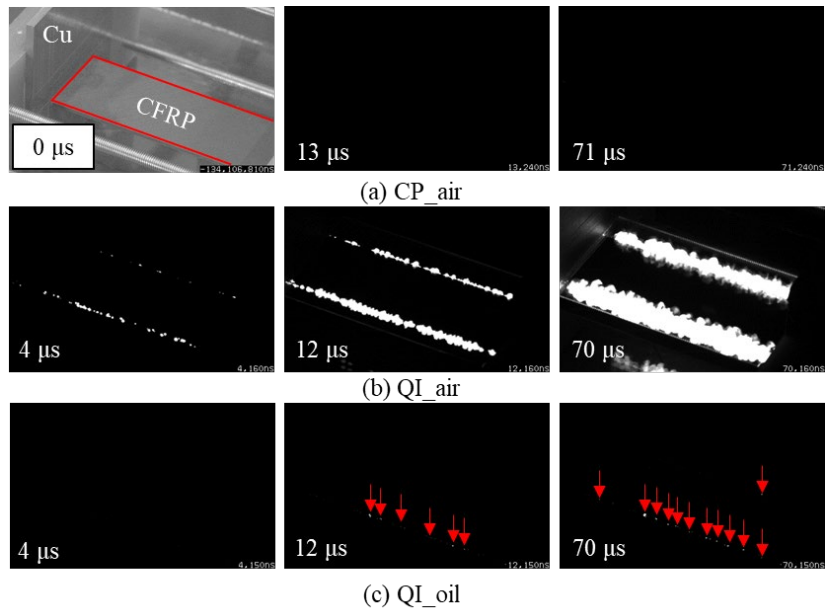
Figure 5.1.2 Edge glow captured by high-speed camera. Red arrows indicate the location of the edge glow.

Fig. 5.1.2 shows typical images captured using a high-speed camera. The left side of Fig. 5.1.2(a) shows the observation area before the test. Owing to the constraints of the testing setup, the left side of the specimen was observed. In the case of unidirectional laminate UD0 and cross-ply laminate CP, nothing was observed in air and silicone oil (Fig. 5.1.2(a)). However, for the QI laminate, an edge glow is observed at the edge of the specimen in air (Fig. 5.1.12(b)). The edge glow occurred approximately 4 μ s after the application of the impulse current. Fig. 5.1.2(c) shows the edge glow phenomenon of the QI in silicone oil. The edge glow was suppressed in silicone oil because the emission intensity of the edge glow was much lower than that in air. The edge glow was more suppressed in silicone oil than in air. The dielectric strength of the silicone oil used in this study was approximately 69 kV/2.5 mm (25°C, water content of 75 ppm), which was an order of magnitude greater than that of air. These experimental results indicate that the edge glow is caused by the

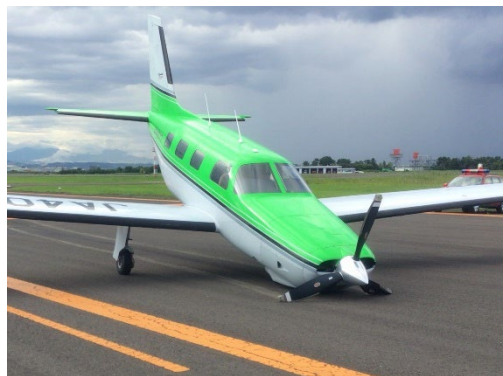
Figure 5.2.1 The aircraft at time of accident

On Sunday, August 1, 2021, at about 11:33 Japan Standard Time (JST: UTC + 9 hours, all times are indicated in JST on a 24-hour clock), a privately owned Piper PA-46-350P, JA4077, sustained substantial damage when landing at Sendai Airport during the landing roll because it tilted forward with the nose down, the propellers and the lower forward fuselage contacting with the runway surface (Figure 5.2.1).

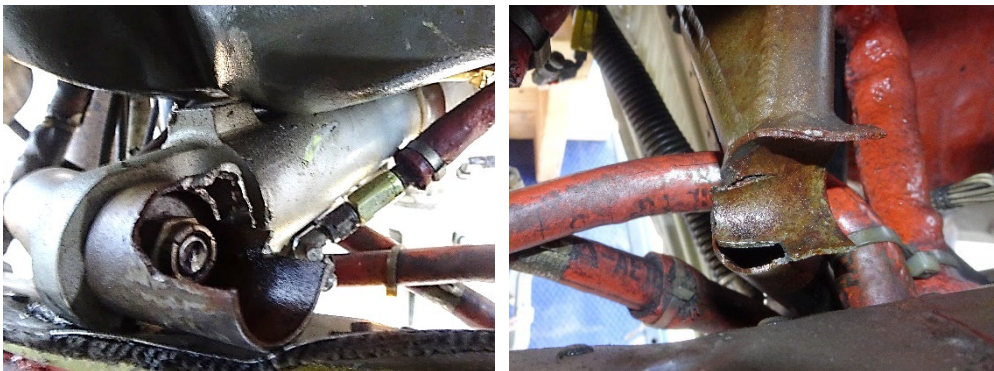
Figure 5.2.2 Fractured portion A (left: actuator side, right: engine mount side)

deformed where the right actuator attachment foot area was fractured, only the left foot was supporting the actuator, and the tip of actuator had been found hit the firewall, deforming part of the firewall. Removal and examination of the Fractured Portion A (Figure 5.2.2) revealed partial corrosion on the fracture surface and blisters had occurred on the back side of the welded part (Figure 5.2.3).
